Mark Duckworth
Martin And Mortimer

DAMP ASSESSMENT - CAISTER NORTH RD HP15 6ND

Survey date: 14th March 2026

Prepared For Mrs Bryony Edwards

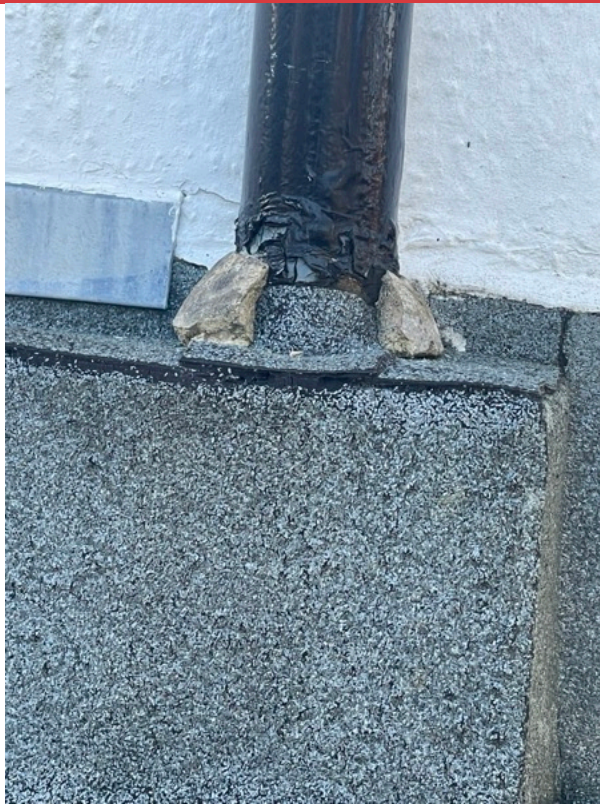
**ITEM 6 BLOCKED RAINWATER
GOODS**

Notably, the rainwater goods serving this extension are partly blocked, in fact in this instance, the downpipe appears to be completely blocked based on leaf litter and other forms of detritus. Please note that all such items require periodic maintenance, especially where deciduous and other forms of trees are evident.

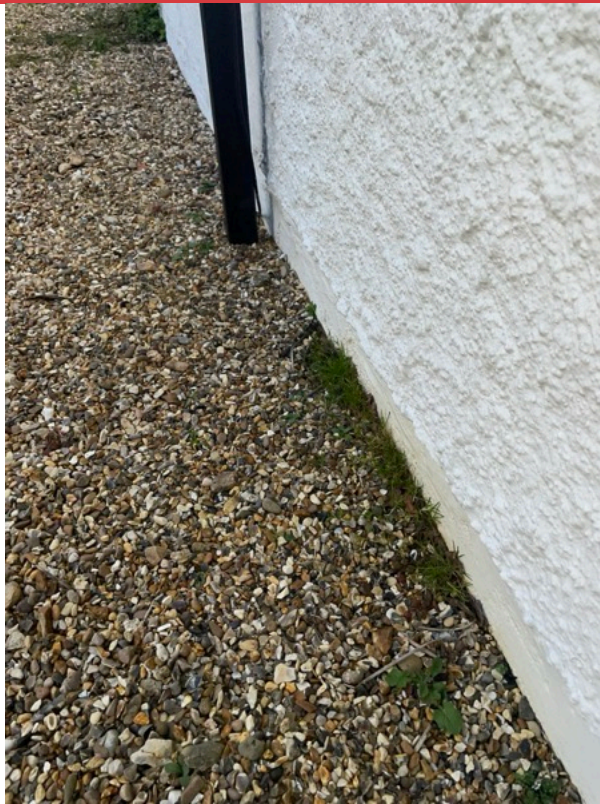
ITEM 9 - FURTHER EXAMPLES OF CONTINUOUS RENDER

It is notable to record that the majority of the external building envelope, includes continuous render, namely which is in direct contact with the external ground. This potentially creates what is known as a 'damp bridge', whereby via a process known as capillary action, moisture can slowly but progressively migrate up via such render, potentially bypassing any damp proof of course set upon the mortar bed typically, two brick courses above ground level.

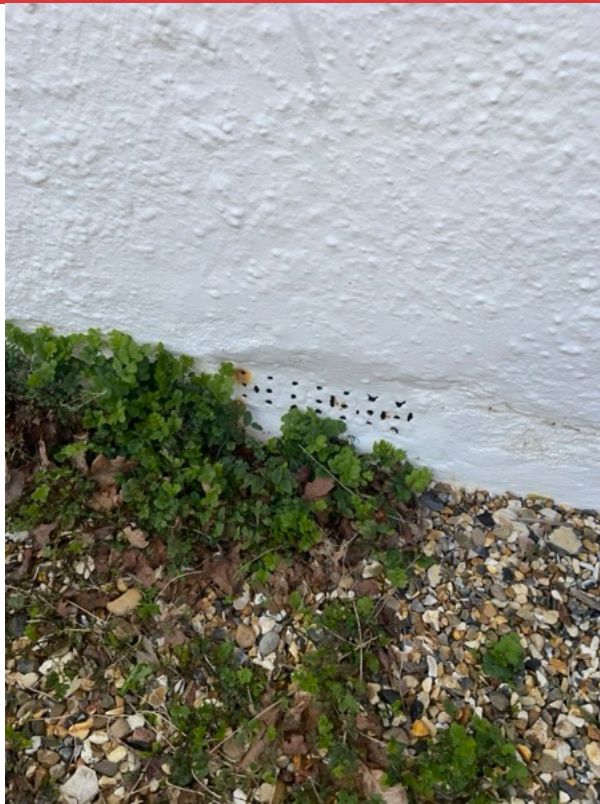
ITEM 10- RENDERED EXTERNAL WALL

It is also notable to record further examples of the continuous render as described above. Furthermore, in view of the soil type including degrees of cohesive clay soils, it is possible that the immediate ground strata will retain levels of moisture throughout the seasons. This is partly illustrated by the growth of grass/plant material at the junction between the wall and the ground.

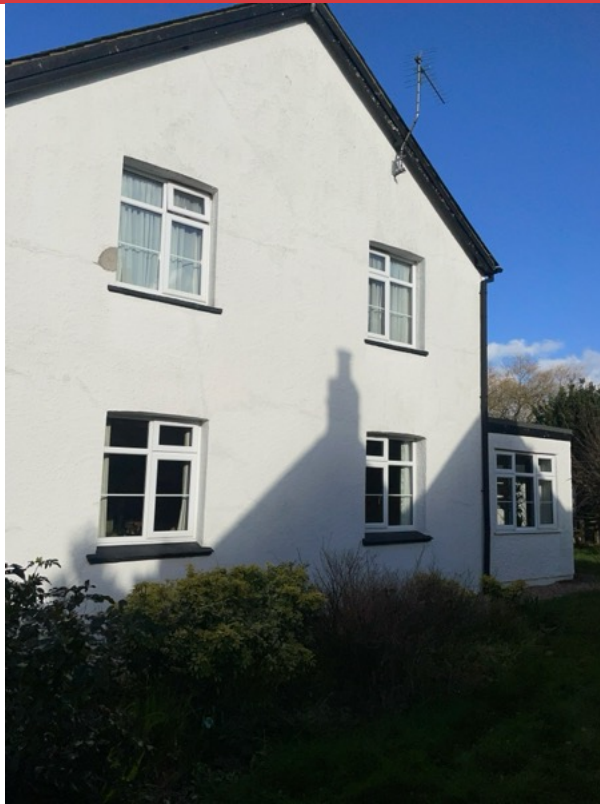
ITEM 11 PARTLY CONCEALED AIR BRICK

Please note, that air bricks of this type remain an essential feature concerning this type of construction. This refers to the suspended wooden floors internally, which require a consistent and robust level of airflow from the outside running through them, in order to avoid potentially serious forms of deterioration. Examples can include an increase in humidity levels, which internally can promote condensation, which can also promote fungal rot in addition to a more conducive environment for woodworm to flourish.

Furthermore, such ventilation serving the underfloor areas, should also have a form of cross ventilation. Fortunately, in this instance I do note air bricks at the front and rear as well as side walls, which will be providing such necessary cross flow ventilation.

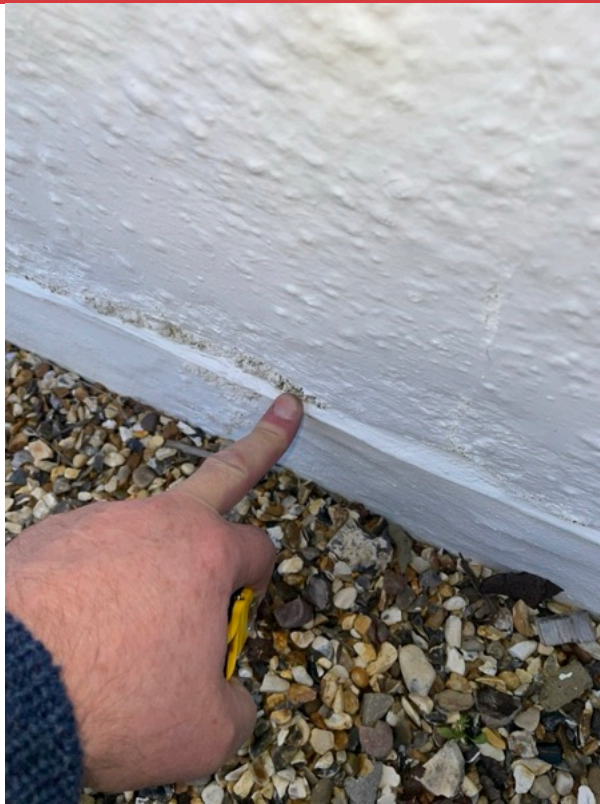
ITEM 12 PAINTED RENDERED WALL

As noted above the render has been repainted and that a number of shrinkage cracks have been filled more recently.

NB. This helps to avoid the more deteriorating effects of the weather, however, such sand and cement based materials can enter via cracks and become trapped within the brickwork. Not least as cement plus synthetic masonry paints can to varying levels inhibit the migration of moisture if it penetrates via cracks.

It would appear that this has occurred in this particular instance, ie. Over many years and which accounts for some of the advanced deterioration of the original internal plaster work. See on re internals.

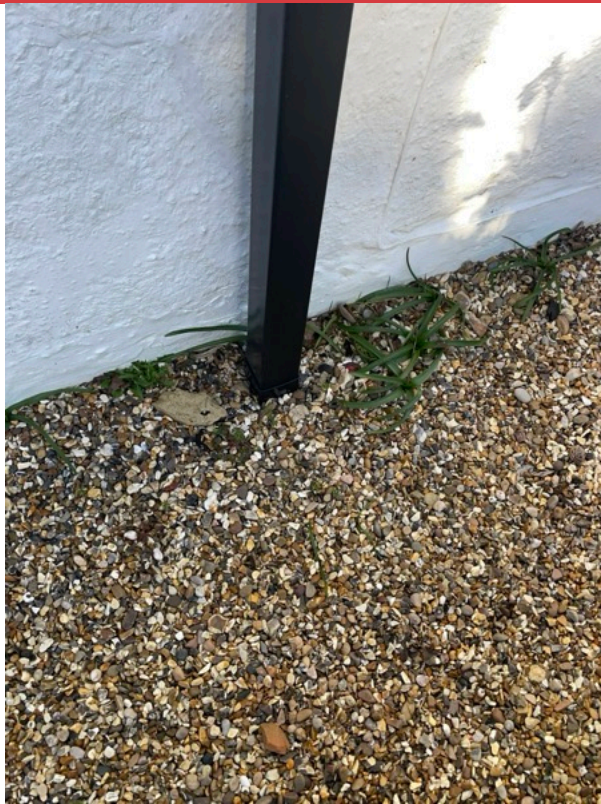
ITEM 13 EFFECTS OF TRAPPED MOISTURE

This results from trapped moisture seeking to evaporate out of the masonry (which is the normal process/direction).

This effect has resulted due to the deposition of mineral salts that are deposited upon the surface of such materials upon evaporation of moisture. It is another example of how the continuous render, has to some extent facilitated certain levels of trapped moisture within the masonry substrate.

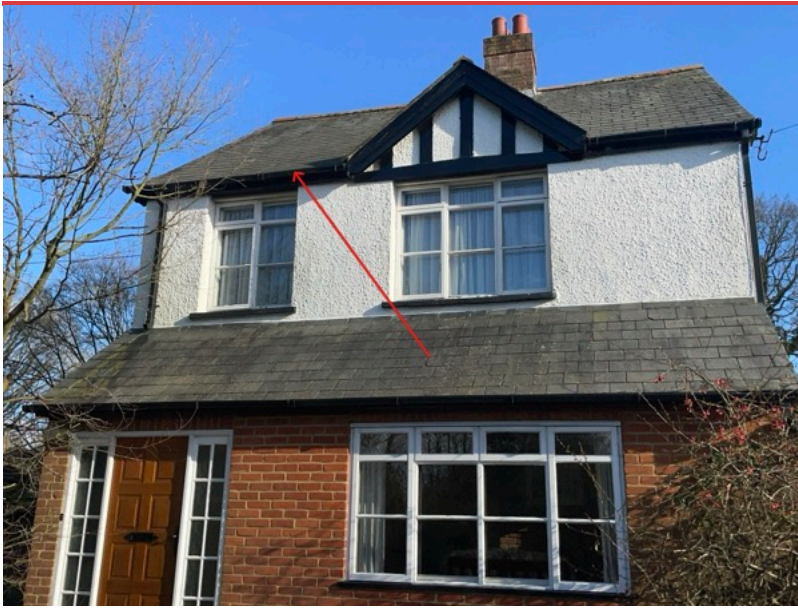
ITEM 14 RAINWATER GOODS INTO A SEALED GULLY

For the most part, the rainwater goods appear to be functioning, although some joints and junctions show signs of leakage. In this case it is useful however to see that the down pipes are mostly terminated into sealed gullies.

I have not, however, been able to determine the efficacy of any soakaways or indeed determine whether the rainwater goods feed into the foul drainage system; otherwise known as a combined drainage system.

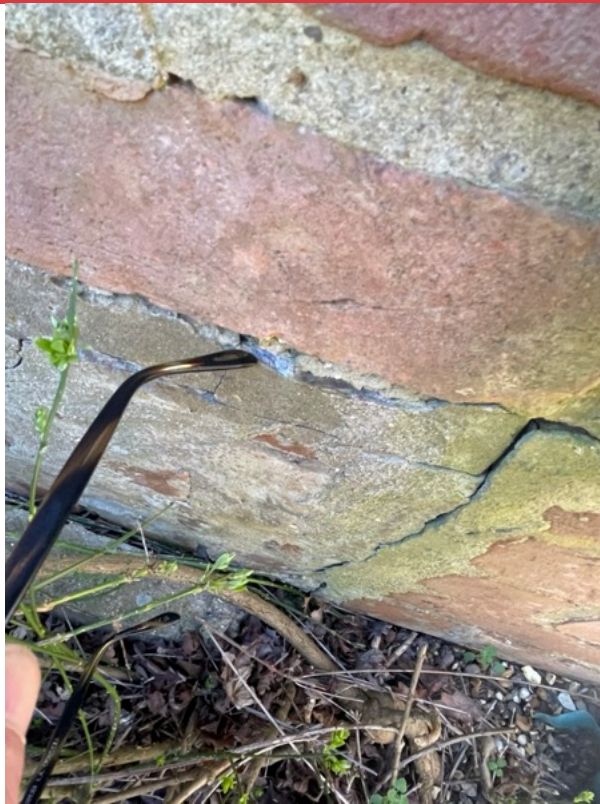
ITEM 24. CEMENT SKIRT AT BASE OF WALL

It is also evident that the cement based skirting at the base of the wall has come away from the outside brickwork in places. This could allow moisture to become trapped at the base, although this does not present a significant risk to the internal habitable wall finishes at this point.

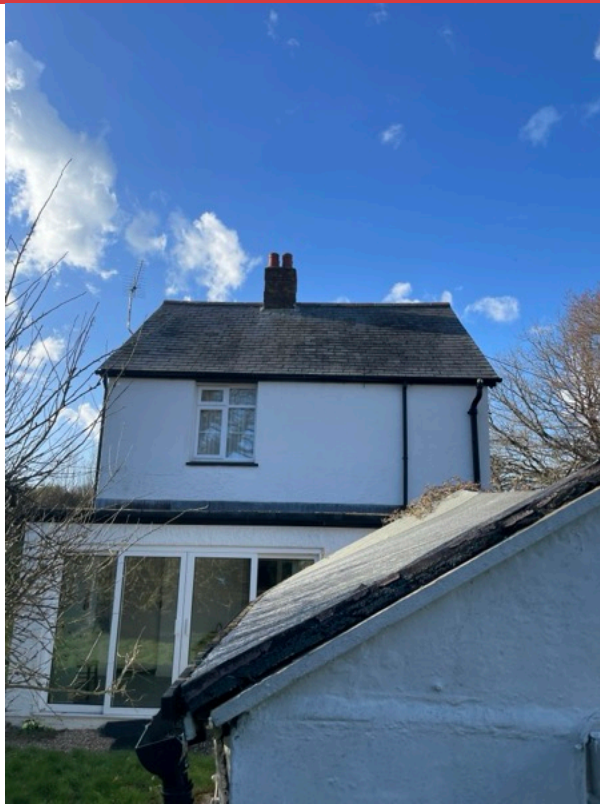
ITEM 27 RAINWATER GOODS

I note that some of the junctions forming the rainwater goods show evidence of previous leakage. This can be quite typical for such plastic materials which, can degrade slightly due to the effects of ultraviolet light and a lack of regular maintenance.

As mentioned above, regular i.e. at least annual full maintenance of all rainwater goods remains essential.

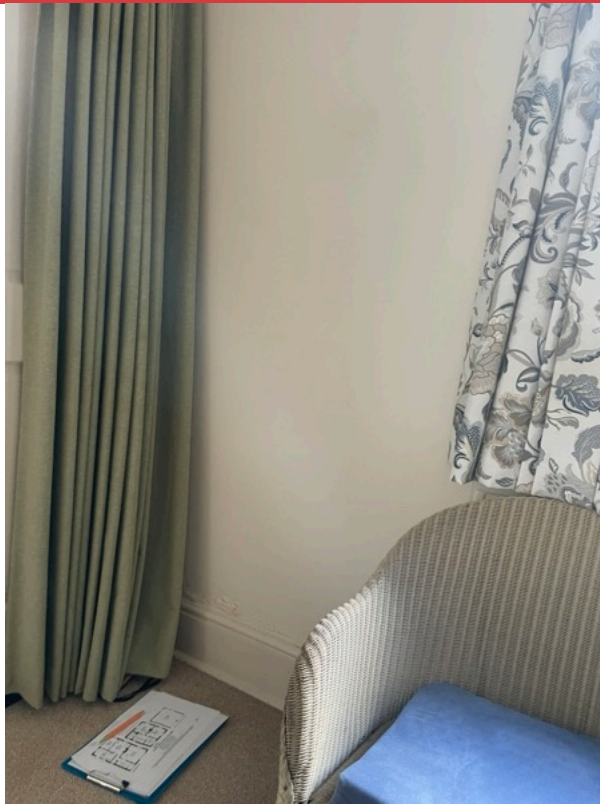
ITEM 30 DAMP PROFILING INTERNAL WALL SPACE

Using a resistance type moisture meter, i.e. in 'pin mode' to assess surface moisture levels, there was evidence of high levels of moisture. Furthermore, this is characterised by peeling paintwork, plus evidence of efflorescence (sulphate salts) as well as in some ways unusually, mould on the adjacent external wall.

Please note that there is a distinction between the effects of masonry salt contamination which arise from external sources of (capillary) moisture, evaporating internally, as distinct from internally created moisture which is the primary causal agent for mould colonisation.

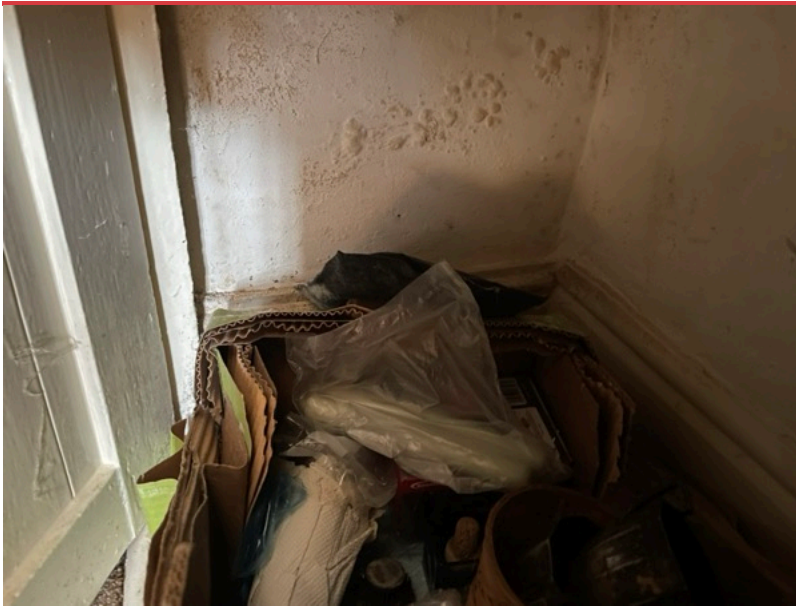
ITEM 31. DAMP PROFILING

I recorded high levels of (capillary) moisture together with characteristic salt contamination above the skirting board for most of the extent of this same section of wall space, albeit at lower levels. The evidence of masonry salts in this manner, indicates that the moisture has been residual in the brickwork and plaster i.e. masonry for some considerable time, namely many years.

It is my opinion, however, that the mould is possibly a more recent occurrence, e.g. previous months. This is part due to the fact that the property has been left empty without heating in previous times, which will have allowed levels of relative humidity during the colder winter season to have risen to consistently high levels.

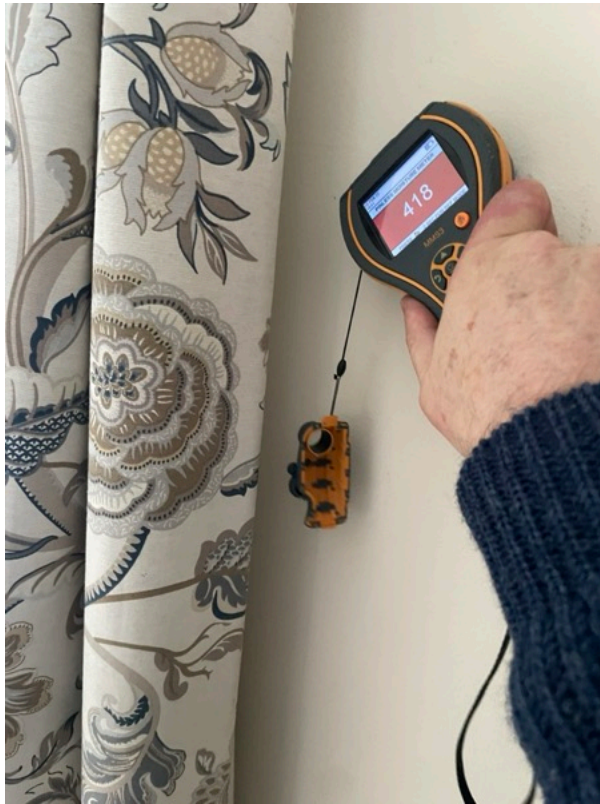
ITEM 32 SALT CONTAMINATION

Again, evidence of salt contaminated plaster, in this instance within the alcove cupboard within the dining room. Please note, that the effect of manifest salts is due to capillary moisture, evaporating upon the surface of the internal plaster work, invariably causing a poor aesthetic appearance. However, it should be noted that this rarely has any significant bearing upon the fundamental structural adequacy of a building, nor does it present a notable health risk. However, instead, it does eventually lead to the delamination of the internal plaster work. See on.

Please note, by using the damp meter in what is known as 'scan mode', this can detect evidence of salts and moisture, up to 15 to 19 mm within the plaster/substrate. In this instance, the above average reading, denotes that there is indeed a degree of trapped moisture in view of the external cement render and (possibly) use of synthetic masonry paint. Such cement based materials can and

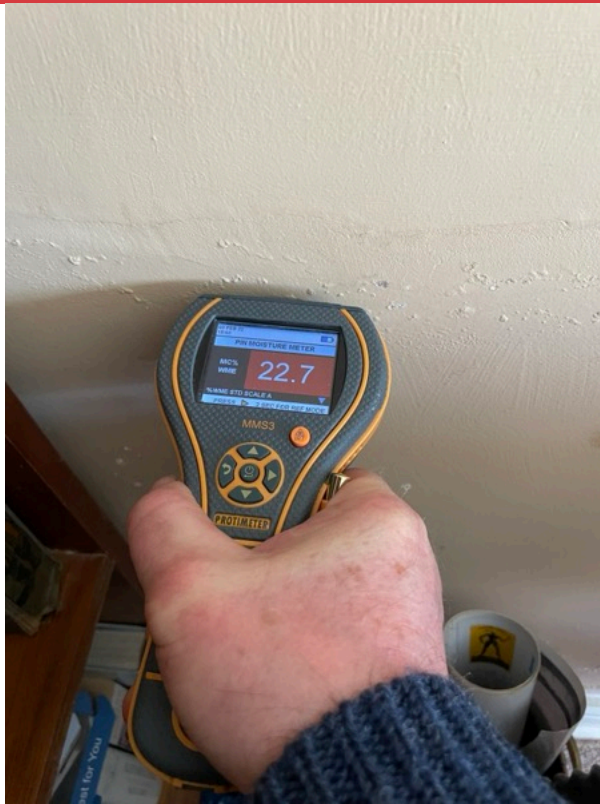
ITEM 35 DAMP FILING - SITTING ROOM

As noted above, extensive evidence of salt contaminated plaster was noted along the entirety of this particular wall section.

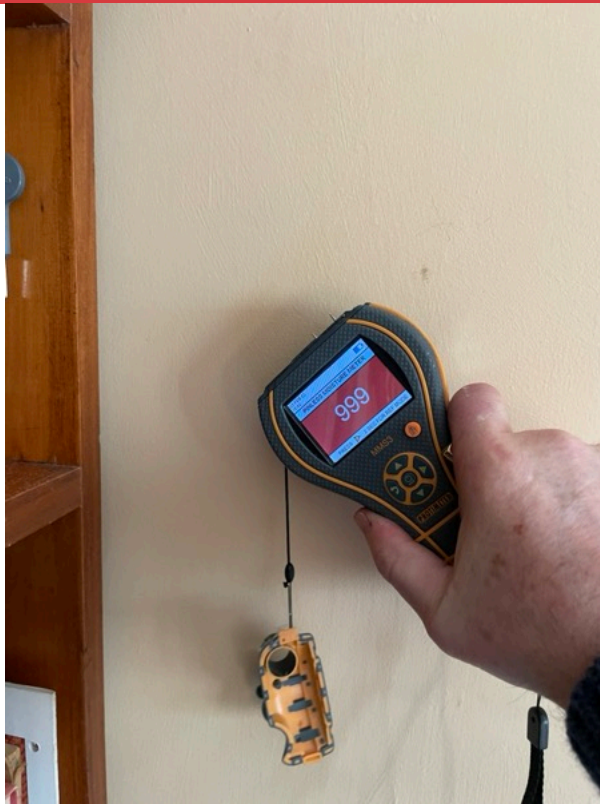
ITEM 36 DAMP PROFILING

I am reasonably confident that the reason that this has failed, is because the external causal influences have evidently not been addressed. This refers to the continuous render, compromising any original damp proof course, together with the propensity for such render to form hairline shrinkage cracks and which intern allows moisture ingress that subsequently becomes trapped within the cement based render.

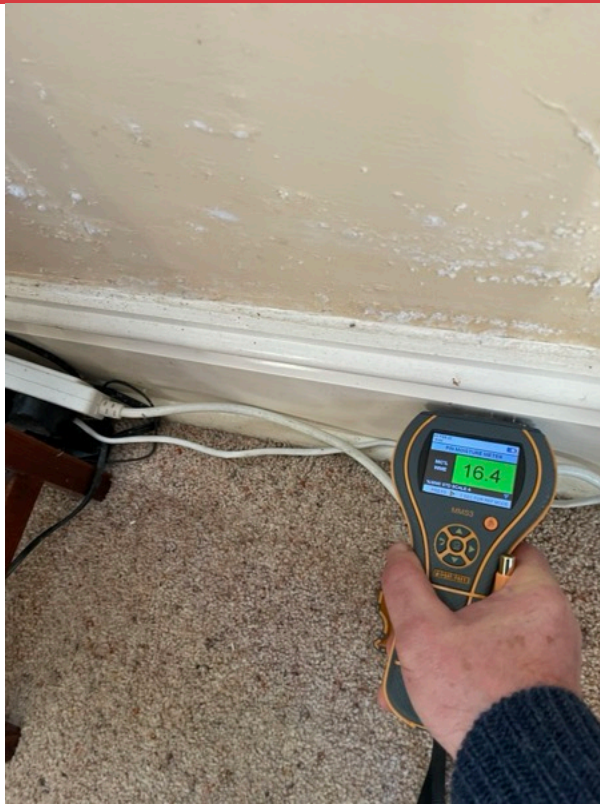
ITEM 37 USING THE METER IN SCAN MODE

Notably, when using the damp meter in scan mode high up the wall profile, excessive readings were obtained. This suggests that there is potentially an accumulation of capillary moisture plus salts within the substrate. I.e. moisture that is trapped, albeit which is not sufficient to manifest with visible salt contamination.

In any event, in view of the condition of the plaster lower down the wall, plus the evidence of moisture higher up, it would be sensible to remove all such plaster from wall to ceiling across the entire south West facing external walls, I.e. in both rooms on both floors.

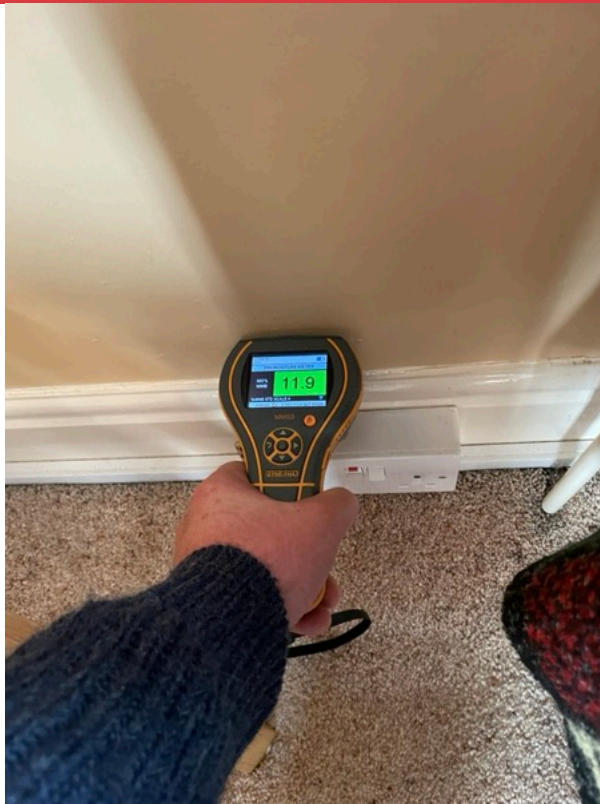
ITEM 39 NIB WALL

It appears that this section of nib wall forms part of the original external wall, prior to the extended section to the right hand side. Further investigation, suggests that gypsum bonding plaster has been applied, and which is highly water absorbent. Therefore, in its previous form as an external wall, applying such (inappropriate gypsum) material, would always allow salt to readily migrate through it, in addition to allow allowing ambient humidity to be readily absorbed also.

It is for these reasons, why the damp staining together with salt is particularly prevalent on this section of nib wall detail.

Please note, in view of this, there is no other option than to remove the entirety of the plaster.

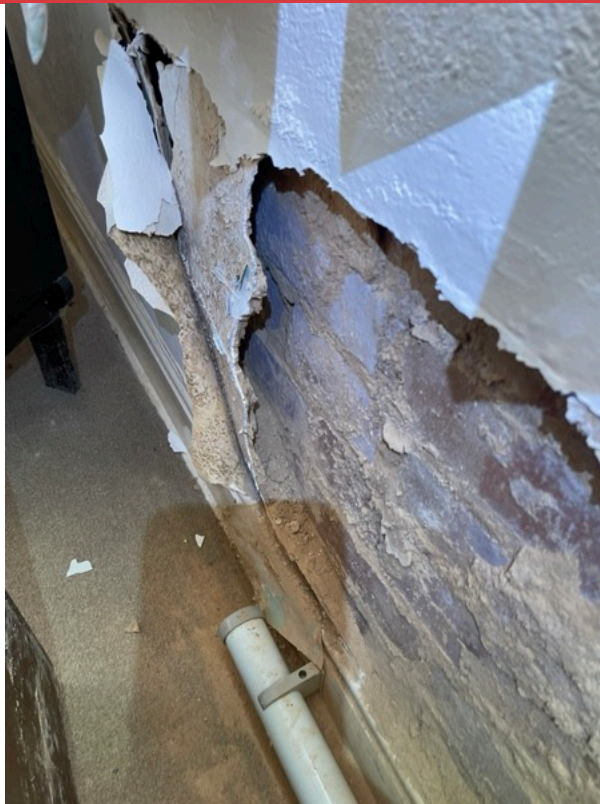
ITEM 49 FIRST FLOOR ASSESSMENT

As noted earlier, it is clear that the external render has trapped moisture which has penetrated the solid brickwork and which over many decades has slowly but progressively created the deterioration as seen.

In essence, the original lime plaster work has come to the end of its useful economic life. As noted earlier, all of the plaster work along this elevation should be removed, and which provides an opportunity to not only make good but provide a thermal upgrade using appropriate forms of insulation at the same time.

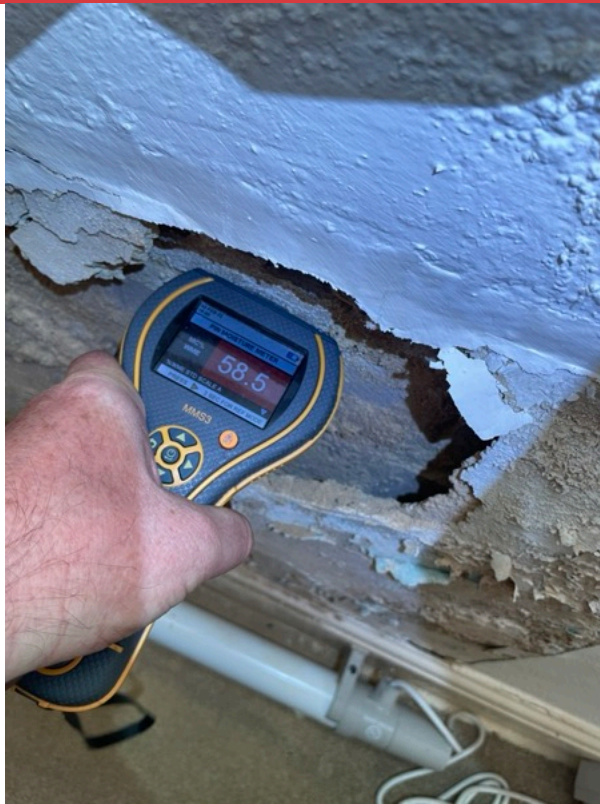
ITEM 50 CLASSIC PLASTER DELAMINATION

Although the appearance of the complete to delamination of the original lime plaster seems dramatic, it is the end result of trapped / penetrating moisture, on this particular weather wall.

It is recommended that consideration be given to formally upgrading the whole of the entirety of the south West facing wall on the first and ground floor floors and which may also incorporate e.g. cavity drainage membrane to prevent the transmission of any inherent masonry salts from penetrating through.

N.b. please note however, there will be many ways to provide such a thermal upgrade, and which will include options for dry lining with insulation materials.

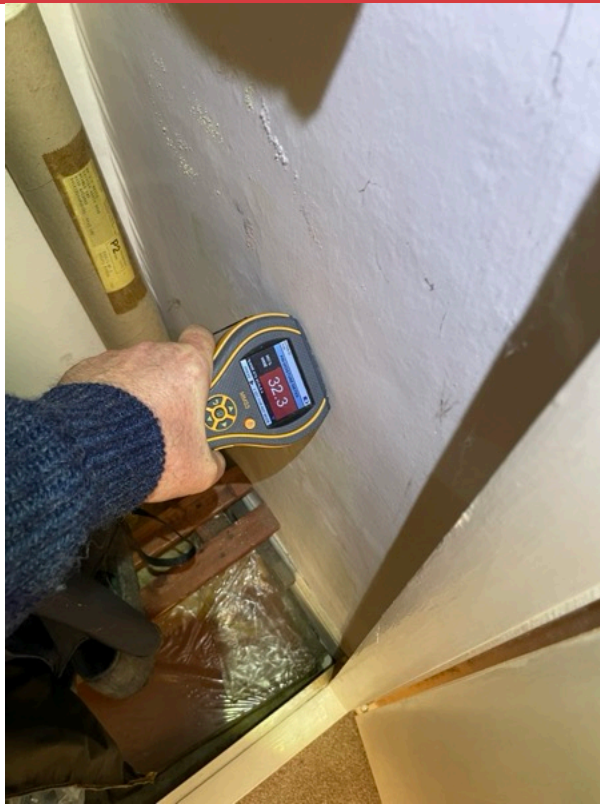
ITEM 51 DAMP PROFILING

When checked with the moisture meter in pin mode, high levels of moisture quite noted.

With regards to future remediation for any purchaser, there will be merit in leaving the walls bare particularly over the spring/summer periods to help facilitate the drying out of the brickwork, before the internal wall finish is reinstated. As above, this should include insulation, and which will also significantly help to stem the current rate of heat loss, which will be high. Please note that the degree of heat migrating through a cold substrate will be excessive compared to a dry wall.
