## **SURVEY REPORT**

**Property:** 31 Holehouse Road  
Kilmarnock  
KA3 7AU

**Ref No:** ROW14212SVY

Property Description: Semi-detached House

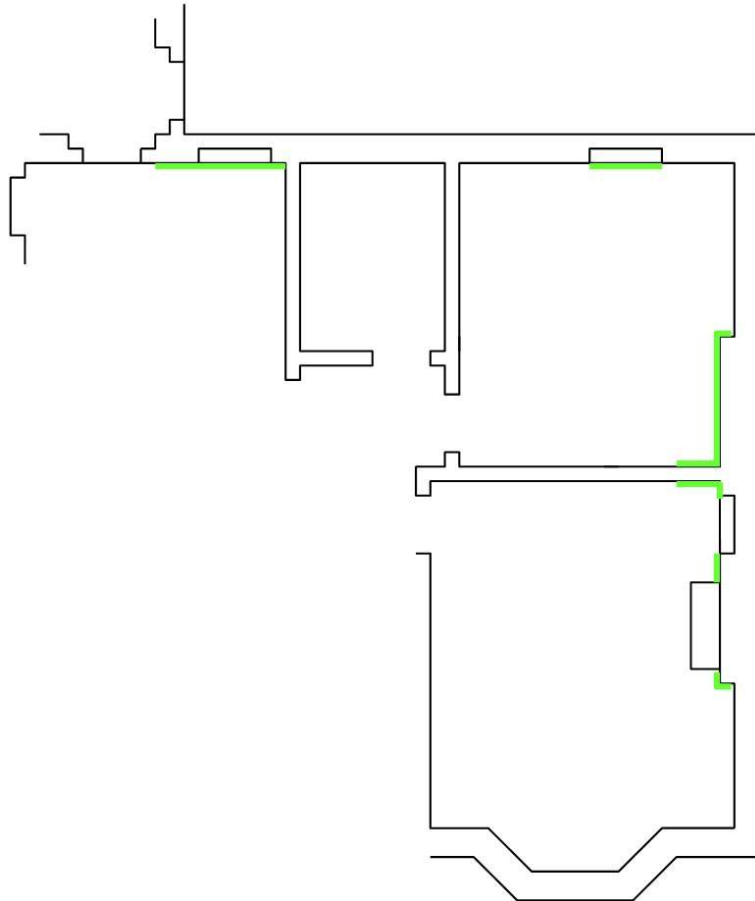
Part Ground Floor Plan

Dampness noted adjacent to fireplaces in Room Front Right and Room Rear Right would appear to be a combination of a build-up of debris in redundant fireplace and residual hygroscopic salt contamination from the historic burning of fossil fuels absorbing moisture from the air.

Damp below windows in Room Rera Right and Room Rear Left would appear to the result of build-up of debris in cavity/ behind linings allowing moisture to bridge from external masonry onto internal surfaces.

Carefully remove and set aside skirtings, facings, etc and reinstate/ renew on completion.

Carefully hack off and remove existing wall plaster to areas and heights as indicated.

Open up redundant fireplace and clear any accumulated debris.

Open up cavity and clear debris as far as practicable below windows.

Install a ventilated, lathed membrane to exposed surfaces of masonry to isolate substrate from plaster finish.

Gypsum bonding plaster or plasterboard is to be applied to membrane followed by finishing plaster.

Install plaster vent to redundant fireplace.
