Mark Duckworth
Martin And Mortimer

DAMP ASSESSMENT - CAISTER NORTH RD HP15 6ND

Survey date: 14th March 2026

Prepared For Mrs Bryony Edwards

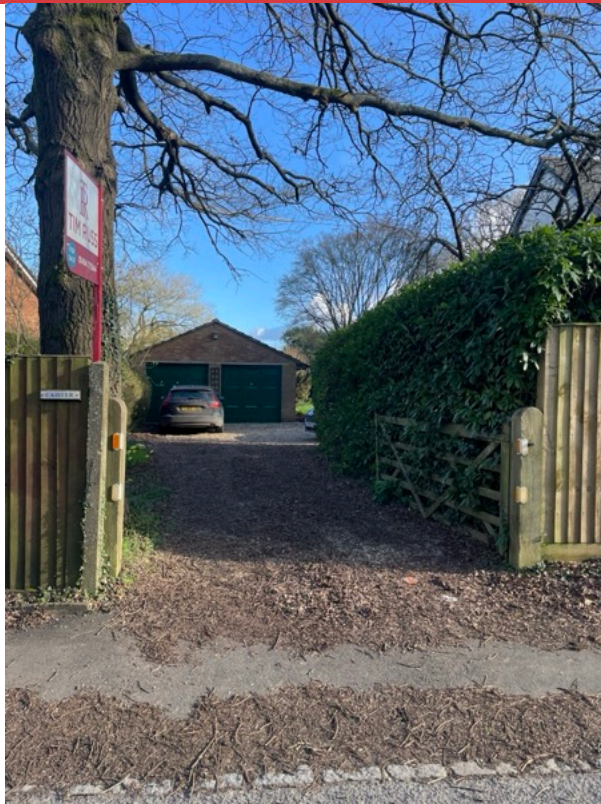
ITEM 1

Location Driveway To Subject Property

I note that the property Face has a north easterly orientation. It is established within a principally rural area, with a degree of tree cover. It appears to date to the later 1920's / 1930's.

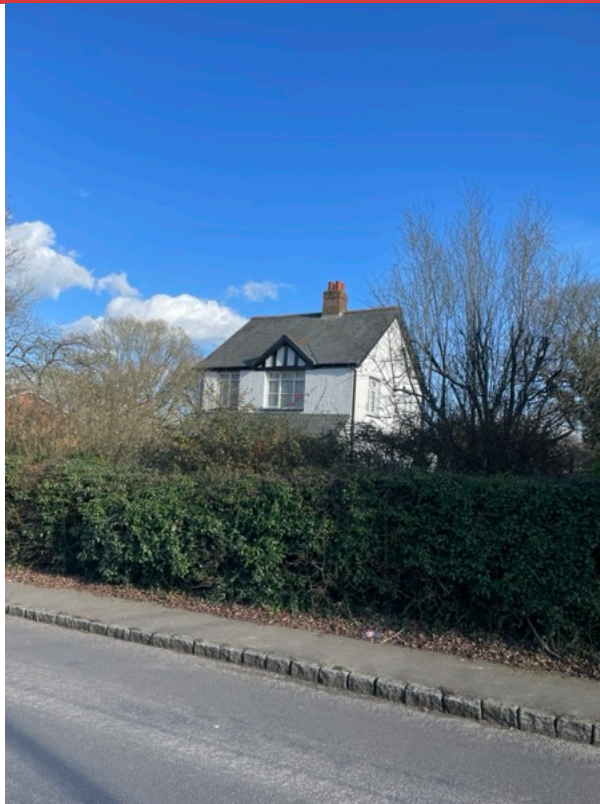
ITEM 2 FURTHER CONTEXTUAL CONSIDERATIONS

Location Viewed From The South South West

The property is established on ground that includes a slight incline running from the south east to the Northwest, but also a more notable gradient is observed along the roadside which runs from the south-west to the north east. From local data regarding the ground strata appears to be based upon clay and flint with chalk and flint at a lower level. This indicates that the ground conditions below the surface levels includes cohesive soil types, and which may hold onto water as opposed to being entirely free draining. Local Flood risk websites referred to the area having a very low risk of surface or other forms of Flood risk. Notwithstanding the tree cover, the right hand side south west facing wall will be more exposed to the prevailing weather.

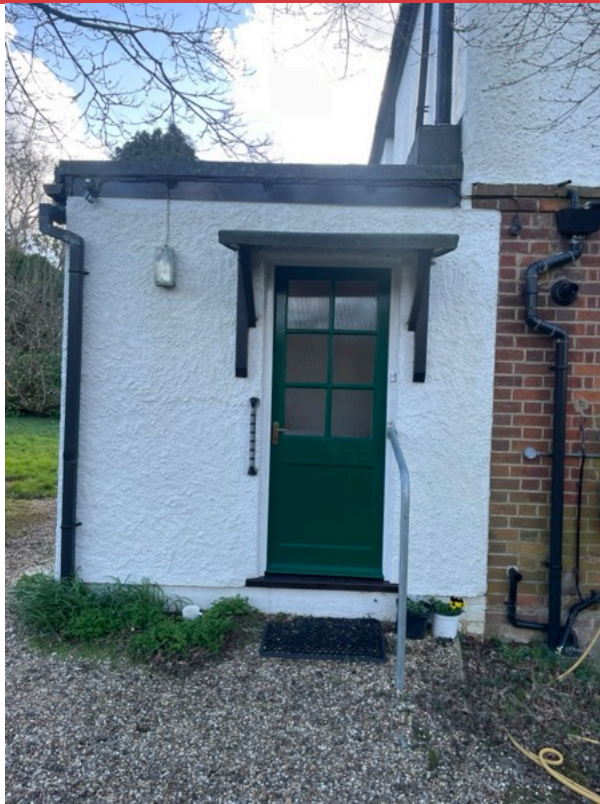
ITEM 3 EVOLUTIONARY HISTORY

Location Rear Flat Roof Extension

It appears that the property has been received at least two extensions in previous decades.

This includes a rear flat roof extension as featured above, built in cavity brickwork.

I also note a single story fair face brick extension on the front elevation, full width and which includes a slate covered mono pitch roof. This incorporates part of the hallway / entrance porch in addition to an adding to the original front reception room.

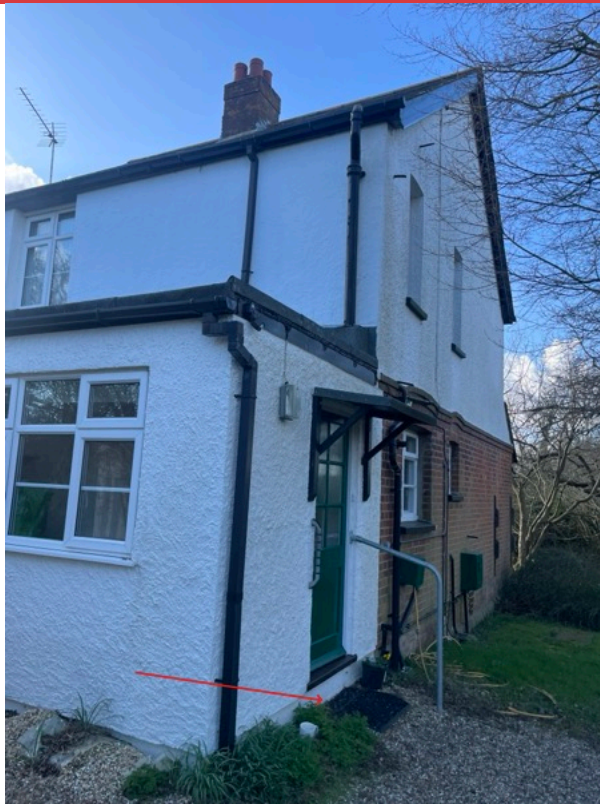
ITEM 4 - EXTERNAL OBSERVATIONS

Location North East Facing Gable Elevation

Notably, the majority of the external building envelope, has been coated in what appears to be a sand and cement based (pebble dash) render. Although painted with masonry paint, please note that while such render provides a degree of weather protection it also can shrink and crack thus allowing moisture within. In this instance, I note that the external walls have been repainted with modern masonry paints in recent times and the cracks filled.

Please note the red arrow showing continuous cement based render which is linked to the external ground level.

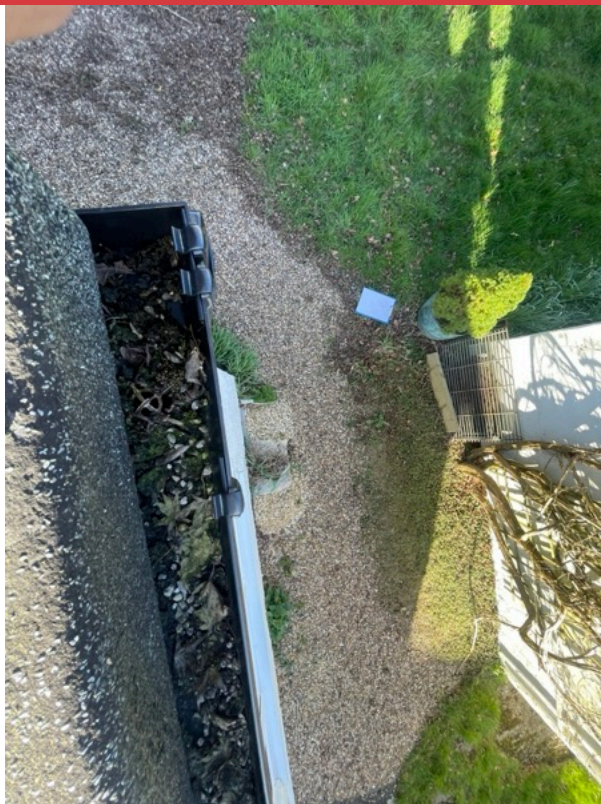
**ITEM 6 BLOCKED RAINWATER
GOODS**

Location North East Corner - Rear
Extension

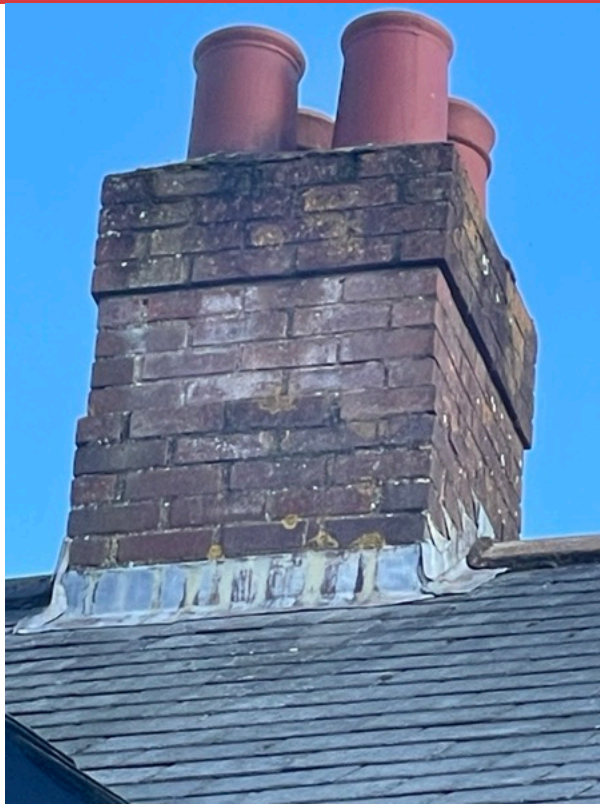
ITEM 16 MAIN (ORIGINAL) CHIMNEY

Location The Chimney Is Broadly Centrally Positioned On The Main Ridge

This includes the effects of wind and rain from the outside, notably the cement flashing which beds the clay pots in place. In this instance, it was not possible to determine the condition of this particular element, although I know that they are two front pots are without caps or rain guards.

Notwithstanding, the brickwork appears to be broadly intact as is the lead flashing at the base between the brickwork and the roof itself. It is possible that this was replaced in recent years at the same time as the roof covering was replaced.

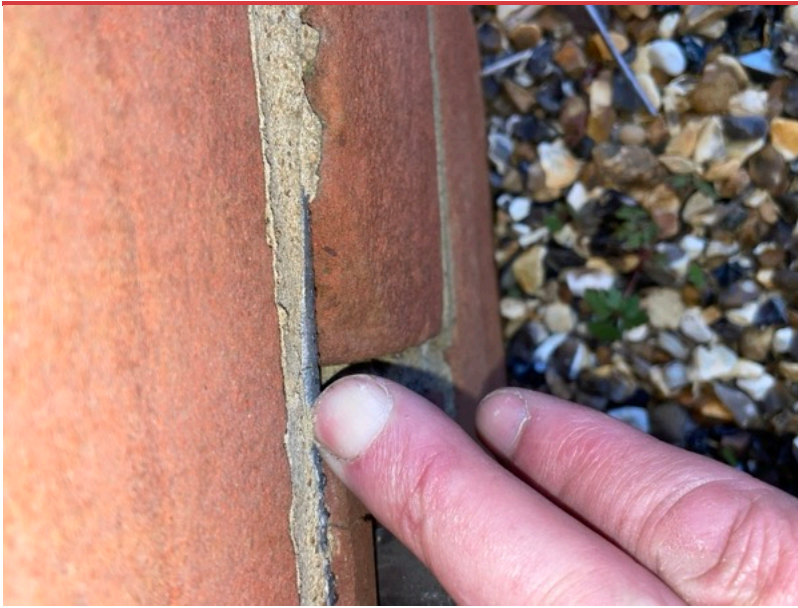
ITEM 18 DAMP PROOF COURSE

Location Base Of Front Elevation

These are particularly effective forms of control against the upward rise of capillary moisture, which occurs mostly through or via the mortar beds below.

I would also add, that the material used in the original property appears to have been based on slate, as a form of damp proof material. See on.

Furthermore, I am of the view that a form of retrospective damp proof coursing has been undertaken particularly along sections of the south West facing gable wall.

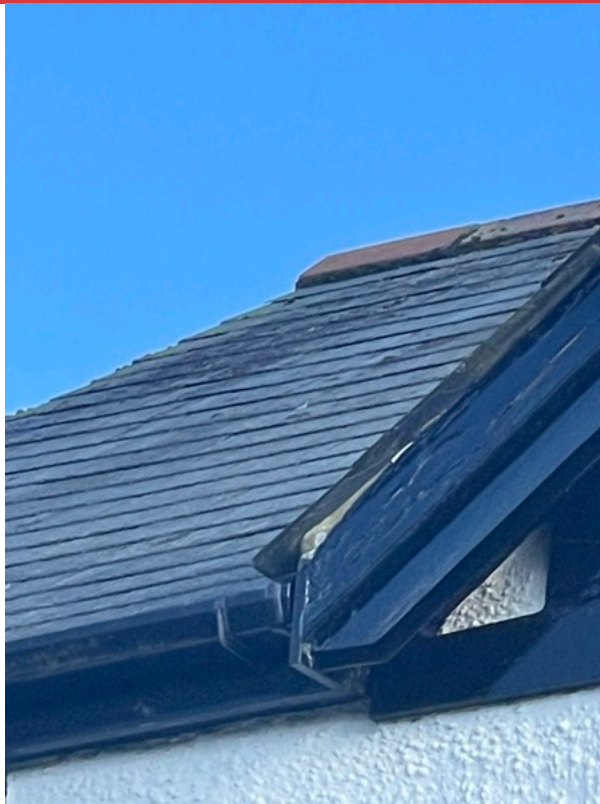
ITEM 19 EXTERNAL JOINERY

Location Front Elevation – Verge
Detail

For the most part, the external joinery appears to be in a fair order. And in this instance, it is evident that maintenance and upkeep has been undertaken over the years. Nevertheless, this will be an ongoing requirement in order to help preserve the longevity of such timber elements.

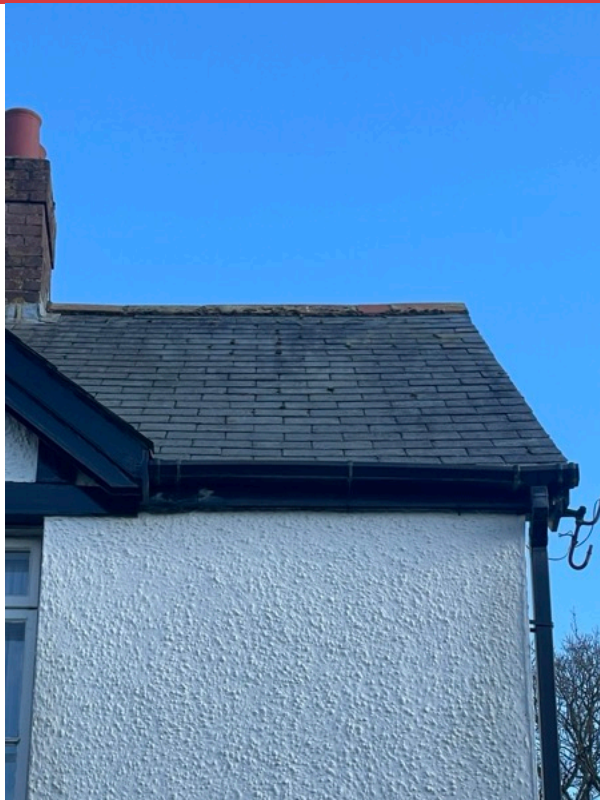
ITEM 20. MAIN ROOF – FRONT ROOF PITCH

Location Right Hand Side

As noted above, the slate roof coverings appear to be in reasonable order, having been replaced possibly 30 - 40 years ago. As such there lifespan will be with reasonable longevity as a roof covering material, such that it will not be in question, except occasional maintenance. There is however, a degree of weathering to the mortar beds fixing in the ridge tiles. These elements may require repointing from time to time, in order to ensure that they remain stable and watertight.

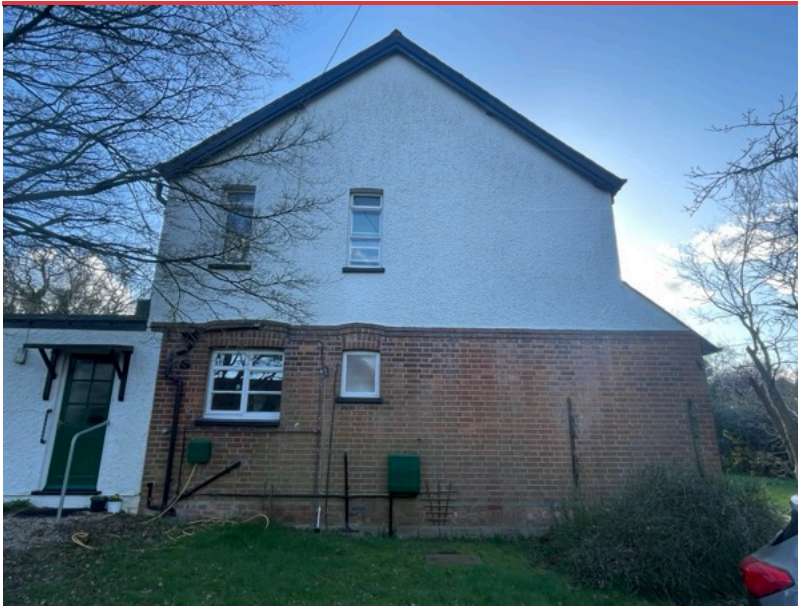
ITEM 21 - EXTERNAL BUILDING ENVELOPE

Location North East Facing Gable Wall

Notably, there is a slight string course detail between the pebble dash render on the first floor and roof gable, plus the bare faced brickwork below. Fortunately, the render has been applied to the outside face of the string course brickwork. This then prevents a buildup of moisture which can otherwise more easily penetrate into the brickwork.

I do note, however, some degree of residue having rundown from the higher sections of the wall in question. This is however not significant.

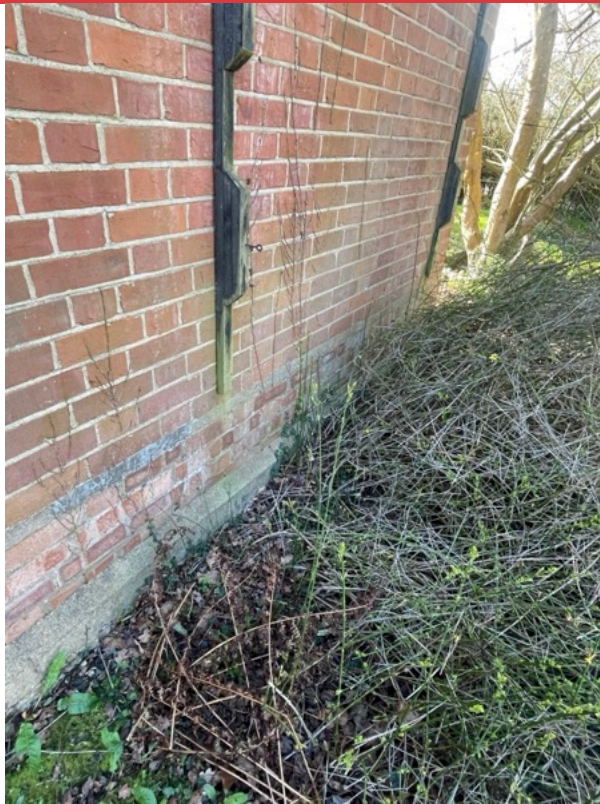
ITEM 22 BARE FACE BRICKWORK PLUS CEMENT FILLET

Location Front Northern Corner Of Property

Also of note, however, is what appears to be an original cement based skirt at the base of the wall. Of equal note, this is somewhat below the level of the damp proof course which at this section is a lot higher in view of the property having been built on sloping ground.

Effectively, the original Damp proof of course along this elevation appears to be fully functional and does not need to be added to or replaced.

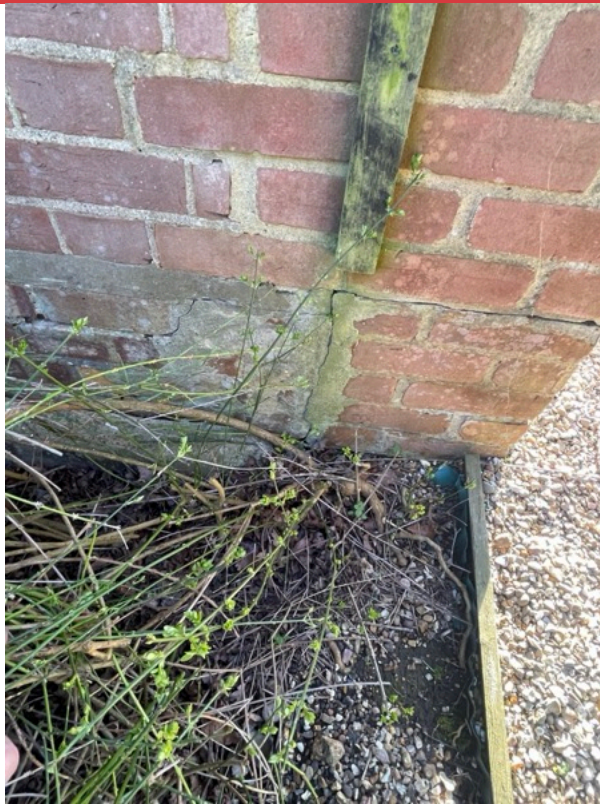
ITEM 23. EXTERNAL BRICKWORK

Location Front Left Hand Corner

This represents a slightly unusual arrangement as it appears that the base brickwork has possibly been adapted at some point but not obviously tied in to the adjacent brick coursework. It is possible that this has been rebuilt for some other reason.

The wider mortar joint to the left hand side is what is called a ribbon line, and includes what is thought to be a slate damp proof course.

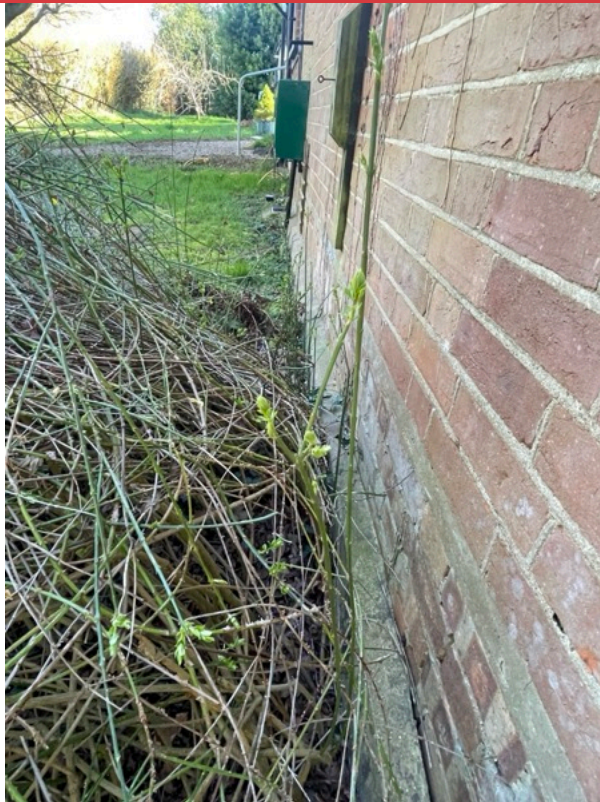
ITEM 24. CEMENT SKIRT AT BASE OF WALL

Location North East Facing

It is also evident that the cement based skirting at the base of the wall has come away from the outside brickwork in places. This could allow moisture to become trapped at the base, although this does not present a significant risk to the internal habitable wall finishes at this point.

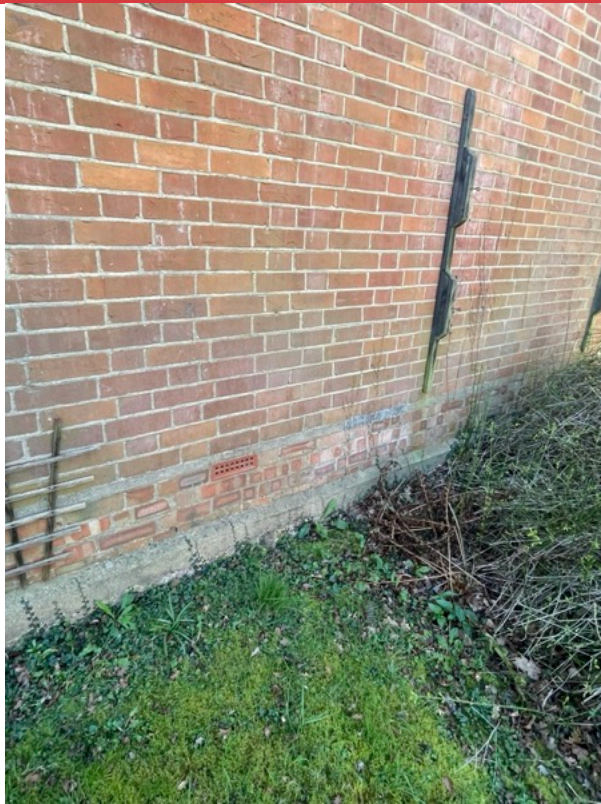
ITEM 26 AIR BRICK

Location North East Facing

This appears to be one of two air bricks serving this elevation.

It will remain important to ensure that shrubbery / plants are not allowed to grow over such areas where the air bricks are located.

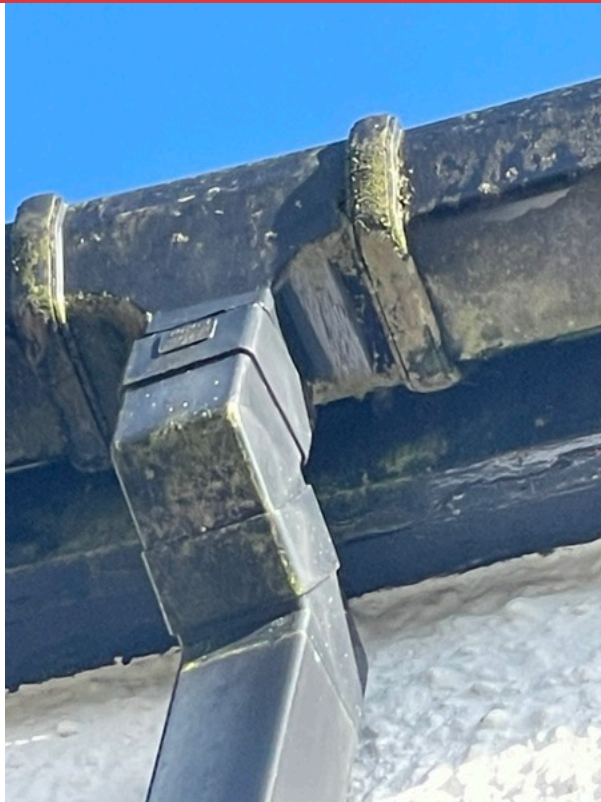
ITEM 27 RAINWATER GOODS

Location Front Right Hand Corner

I note that some of the junctions forming the rainwater goods show evidence of previous leakage. This can be quite typical for such plastic materials which, can degrade slightly due to the effects of ultraviolet light and a lack of regular maintenance.

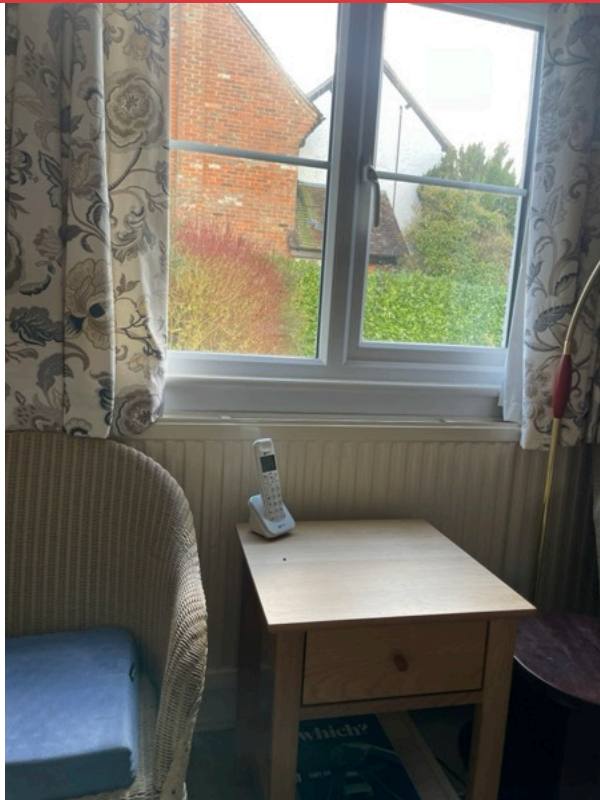
ITEM 29 INTERNALS

Location Dining Room-Looking South West

It is particularly notable, that the evident physical manifestations of moisture have for the very most part all occurred along the south west facing internal wall space, i.e. both on ground as well as on the first floor levels.

Starting in the rear right hand corner of the dining room, my internal assessments focus mainly in these areas, although other areas were checked also.

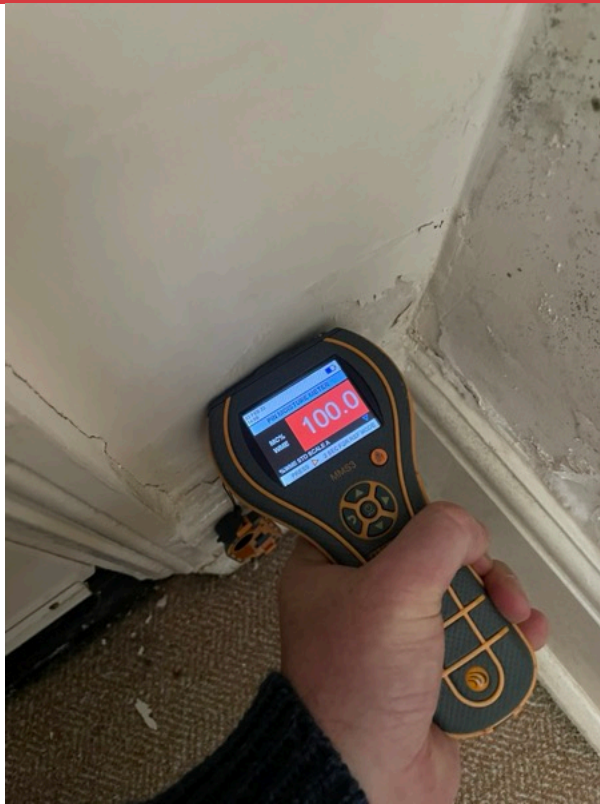
ITEM 30 DAMP PROFILING INTERNAL WALL SPACE

Location South East Corner Of
Dining Room

Using a resistance type moisture meter, i.e. in 'pin mode' to assess surface moisture levels, there was evidence of high levels of moisture. Furthermore, this is characterised by peeling paintwork, plus evidence of efflorescence (sulphate salts) as well as in some ways unusually, mould on the adjacent external wall.

I recorded high levels of (capillary) moisture together with characteristic salt contamination above the skirting board for most of the extent of this same section of wall space, albeit at lower levels. The evidence of masonry salts in this manner, indicates that the moisture has been residual in the brickwork and plaster i.e. masonry for some considerable time, namely many years.

It is my opinion, however, that the mould is possibly a more recent occurrence, e.g. previous months. This is part due to the fact that the property has been left empty without heating in previous times, which will have allowed levels of relative humidity during the colder winter season to have risen to consistently high levels.

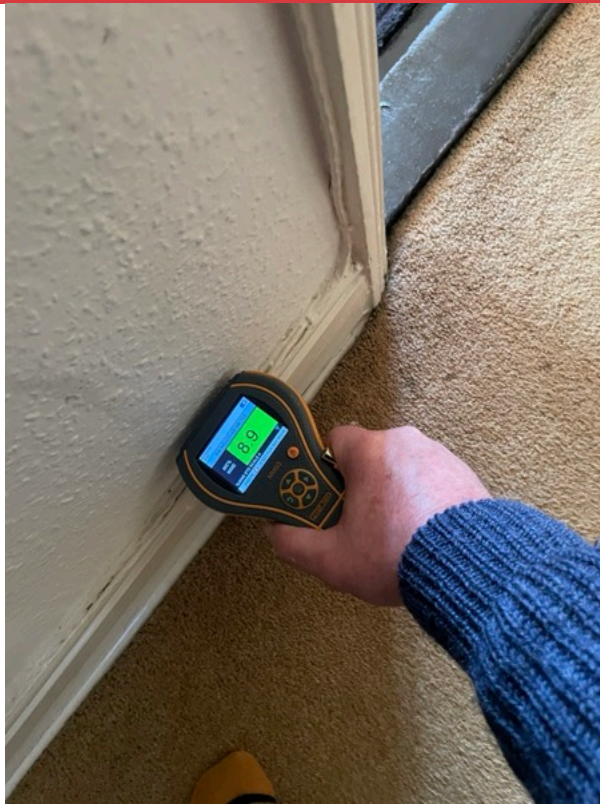
ITEM 34 INTERNAL WALL SPACE

Location Ground Floor Hallway

By comparison to the external south West facing wall, for the most part, the remaining internal walls revealed very little if any moisture or indeed salt contamination.

This is as expected in the property of this type and age.

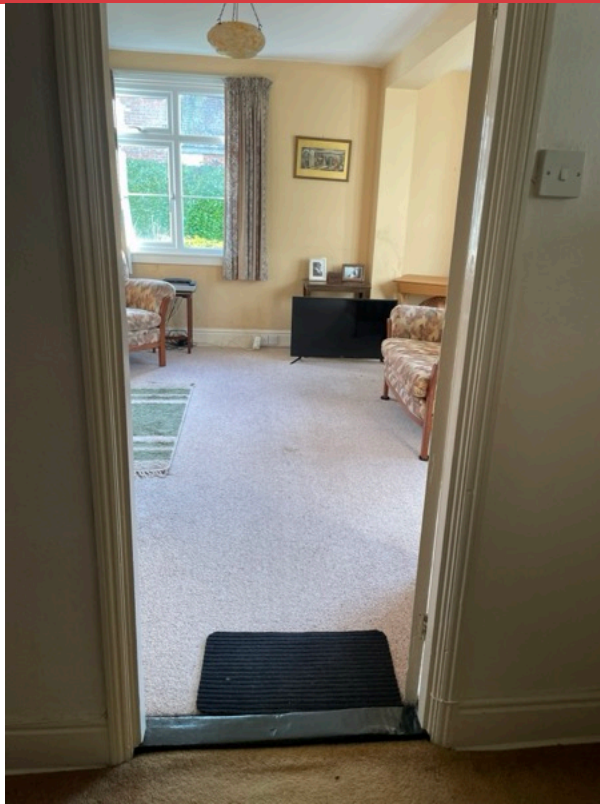
ITEM 35 DAMP FILING - SITTING ROOM

Location Ground Floor-Sitting Room

As noted above, extensive evidence of salt contaminated plaster was noted along the entirety of this particular wall section.

By comparison, e.g. The northern corner of this sitting room, revealed no such moisture.

I am reasonably confident that the reason that this has failed, is because the external causal influences have evidently not been addressed. This refers to the continuous render, compromising any original damp proof course, together with the propensity for such render to form hairline shrinkage cracks and which intern allows moisture ingress that subsequently becomes trapped within the cement based render.

In any event, in view of the condition of the plaster lower down the wall, plus the evidence of moisture higher up, it would be sensible to remove all such plaster from wall to ceiling across the entire south West facing external walls, I.e. in both rooms on both floors.

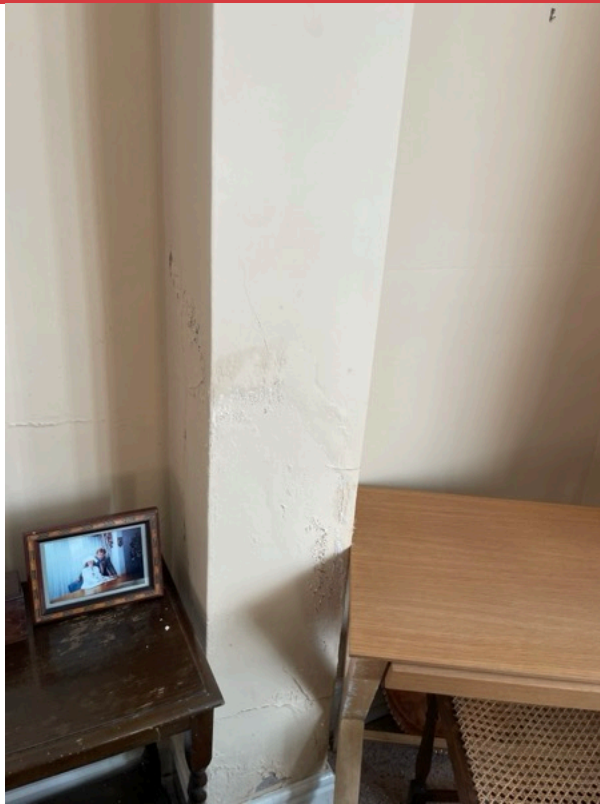
ITEM 39 NIB WALL

Location South West Side Of
Sitting Room

It appears that this section of nib wall forms part of the original external wall, prior to the extended section to the right hand side. Further investigation, suggests that gypsum bonding plaster has been applied, and which is highly water absorbent. Therefore, in its previous form as an external wall, applying such (inappropriate gypsum) material, would always allow salt to readily migrate through it, in addition to allow allowing ambient humidity to be readily absorbed also.

It is for these reasons, why the damp staining together with salt is particularly prevalent on this section of nib wall detail.

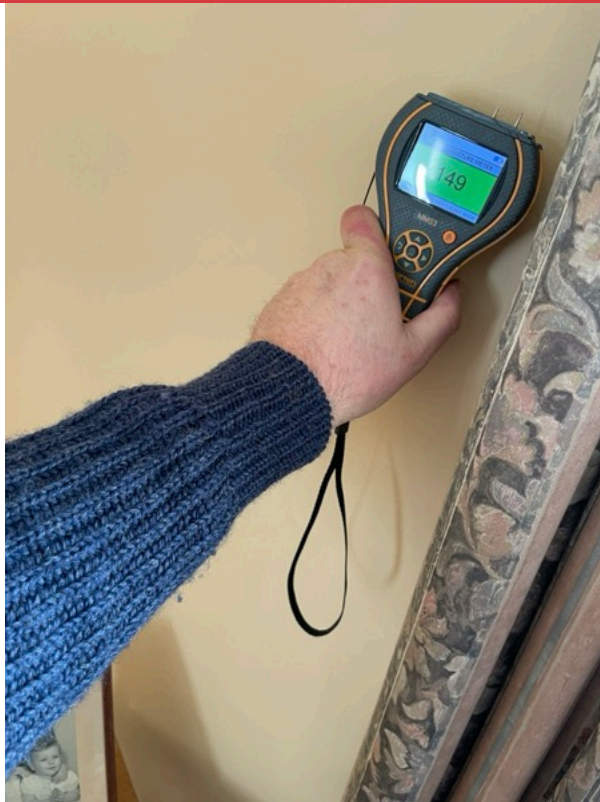
ITEM 41 DAMP PROFILING HIGHER UP THE WALL

Location Front North West Facing External Wall

Again, using the meter in scan mode, there is no evidence of residual or trapped moisture within the wall profile higher up.

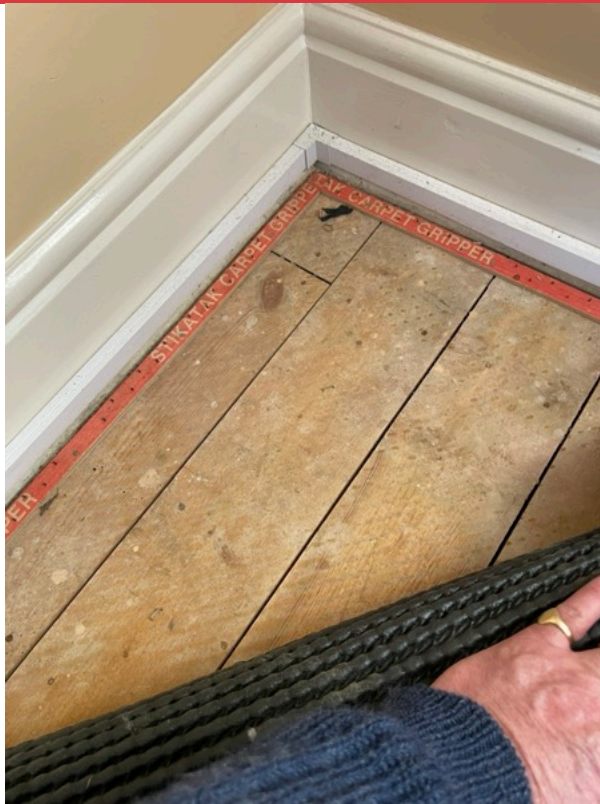
ITEM 42 ORIGINAL PINE FLOORBOARDS

Location North West Corner Of Sitting Room

Although I was unable to pull back extensive amounts of carpeting and underlay material, the area that I did expose, revealed no evidence of deterioration or any sign of e.g. Woodworm. I cannot vouch, however, for the subfloor areas below the floorboards.

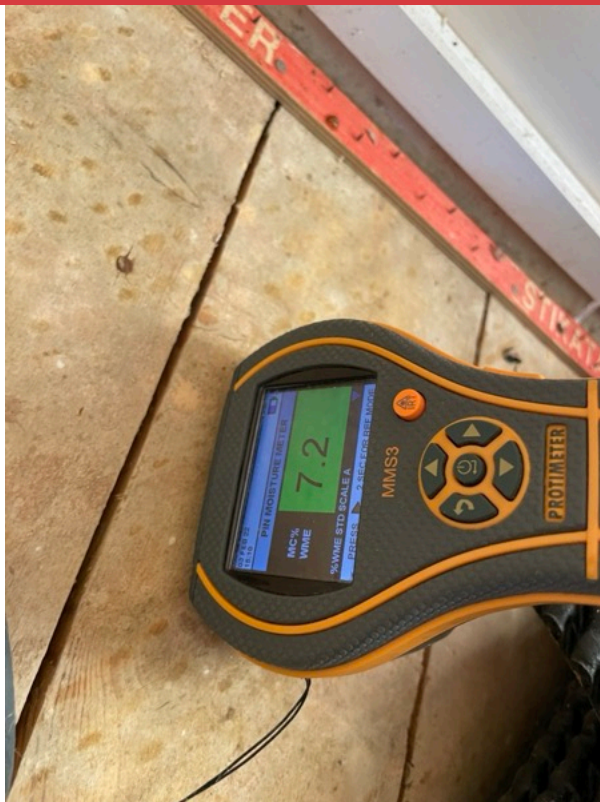
ITEM 43 TESTING FOR MOISTURE

Location Same West Corner Of Sitting Room

The moisture level recording 7.2% is very low and in view of the gaps between the abutted floorboards, indicates that there is likely to be a reasonable amount of subfloor ventilation present.

Please note, at this level of moisture, any risk of deterioration is again particularly low.

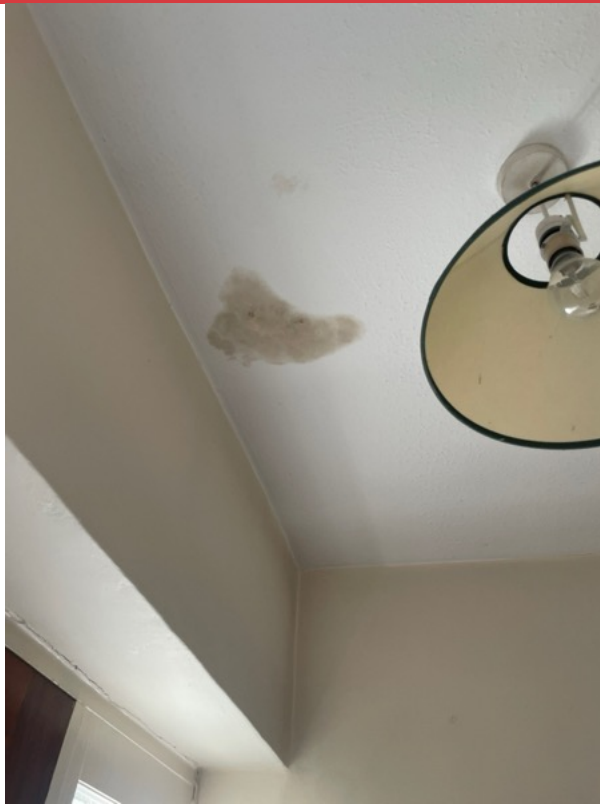
ITEM 44 CEILING STAIN

Location Front Enclosed Porch Area

I was unable to determine the possible causes of the stain within the ceiling.

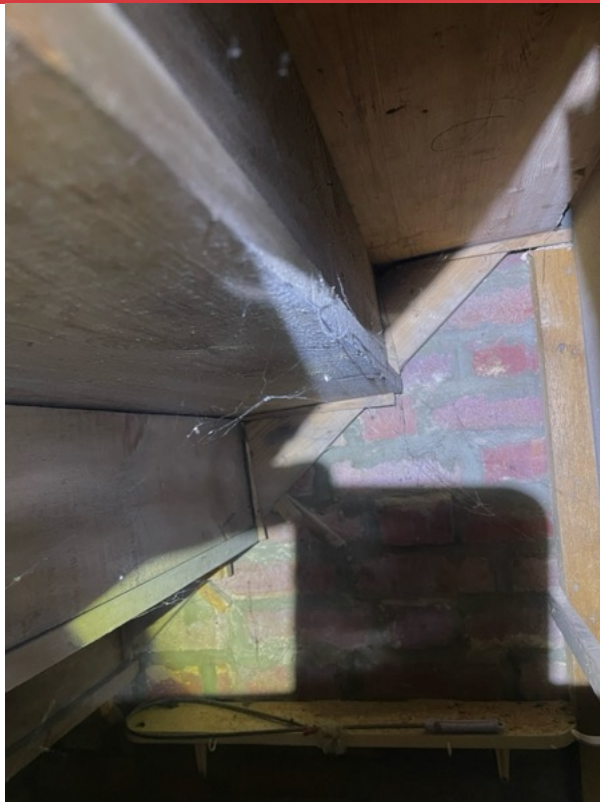
ITEM 46 THE ORIGINAL PINE TIMBER STAIRCASE

Location Under Stair Cupboard

Notably, the original staircase has been constructed from comparatively slow growing quality pine wood, which is a strong and durable timber material.

It can also be quite resistant to woodworm attack and other Wood boring beetles. In this instance, I saw no evidence of flight holes from either present or past woodworm infestations.

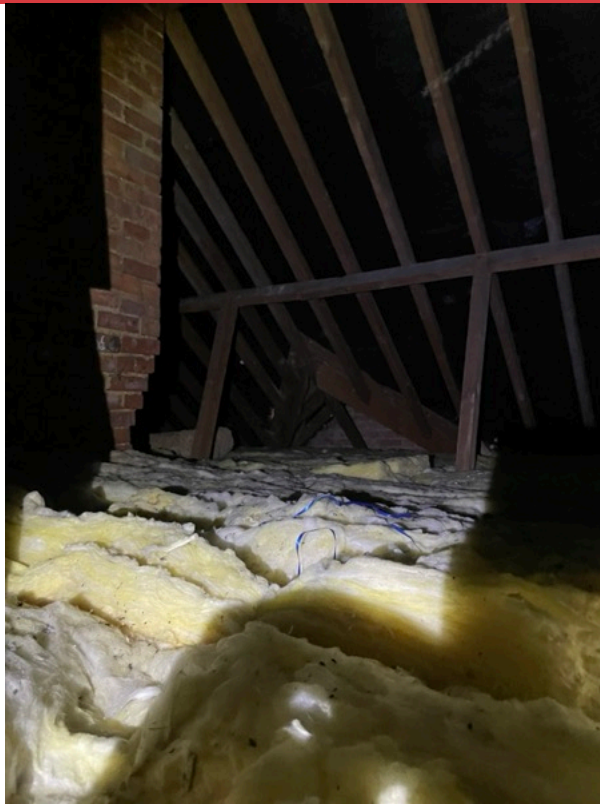
ITEM 47 HEAD AND SHOULDERS ROOF INSPECTION

Location Main Roof Void

Firstly, the roof has been renewed in terms of its outer covering (slate) and which at the same time has included the adding of a secondary barrier using in this case sarking felt. The felt appear to be consistent and in reasonable order. Although there are no obvious roof vents, I did sense a degree of air movement in what is a fairly large and expansive roof space.

The insulation material appears to be at more modern levels, namely between 250 and 300 mm in depth. Please note that although some pipework and header tanks remains in situ, I could not assess all, or the full extent of the pipework. That which was exposed appears to have satisfactory levels of foam insulation lagging.

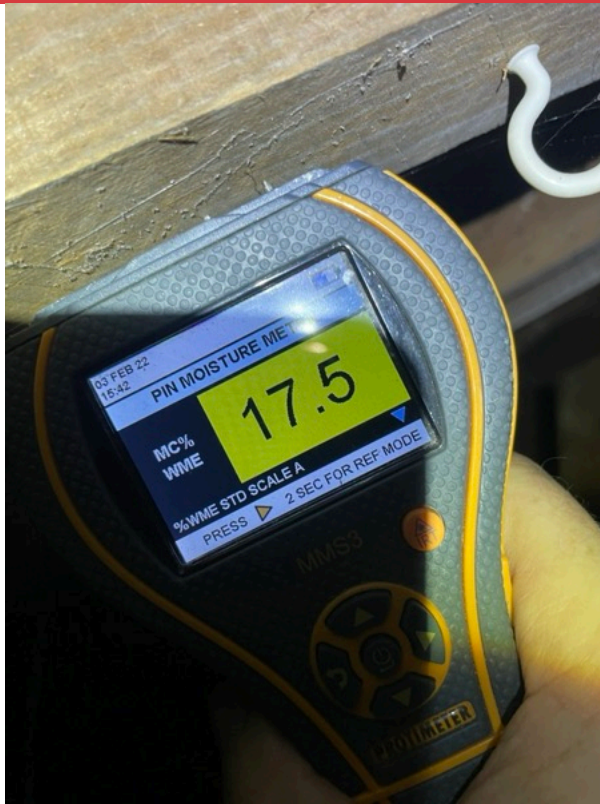
ITEM 48 MOISTURE ASSESSMENT IN THE TIMBER

Location Rear Self East Facing
Roof Pitch

The level of moisture recorded at 17.5% is satisfactory, and presents little or no risk to the timbers at this level. Furthermore, it suggests that the roof space does have a degree of ventilation.

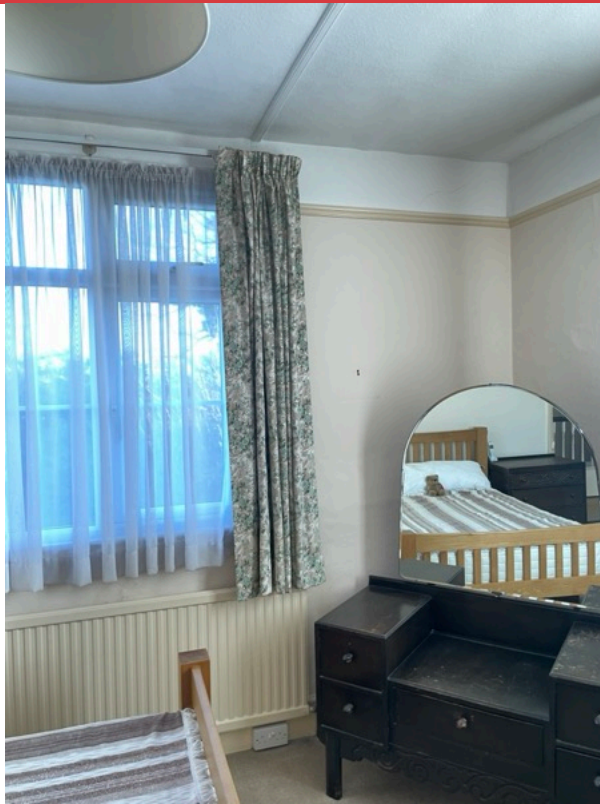
ITEM 49 FIRST FLOOR ASSESSMENT

Location Rear Right Hand Side
Bedroom

As noted earlier, it is clear that the external render has trapped moisture which has penetrated the solid brickwork and which over many decades has slowly but progressively created the deterioration as seen.

In essence, the original lime plaster work has come to the end of its useful economic life. As noted earlier, all of the plaster work along this elevation should be removed, and which provides an opportunity to not only make good but provide a thermal upgrade using appropriate forms of insulation at the same time.

It is recommended that consideration be given to formally upgrading the whole of the entirety of the south West facing wall on the first and ground floor floors and which may also incorporate e.g. cavity drainage membrane to prevent the transmission of any inherent masonry salts from penetrating through.
