Home Report

SHEPHERD
CHARTERED SURVEYORS

Single Survey

Property address	Ashton Tongland Kirkcudbright DG6 4LT
Customer	Miss Louisa Mansfield (Power of Attorney)
Customer address	Ashton Tongland Kirkcudbright DG6 4LT
Prepared by	Shepherd Chartered Surveyors
Date of inspection	08/05/2025

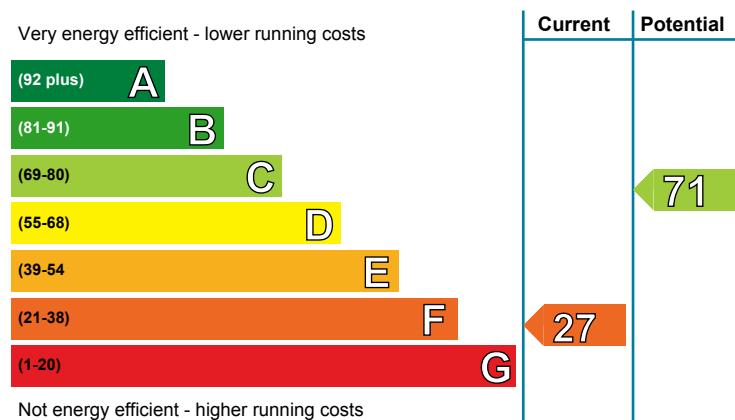
Energy Efficiency Rating

This graph shows the current efficiency of your home, taking into account both energy efficiency and fuel costs. The higher this rating, the lower your fuel bills are likely to be.

Your current rating is **band F (27)**. The average rating for EPCs in Scotland is **band D (61)**.

The potential rating shows the effect of undertaking all of the improvement measures listed within your recommendations report.

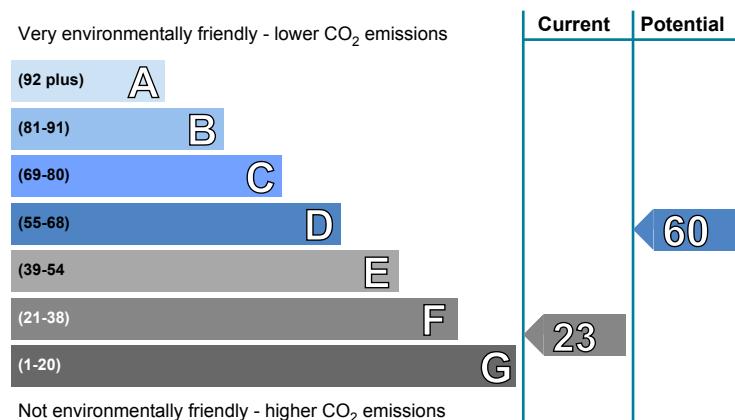
Environmental Impact (CO₂) Rating

This graph shows the effect of your home on the environment in terms of carbon dioxide (CO₂) emissions. The higher the rating, the less impact it has on the environment.
