# Home Report

# Single Survey

| Property address | Moodlaw<br>Eskdalemuir<br>Langholm<br>DG13 0QT |

## PART 1 - GENERAL

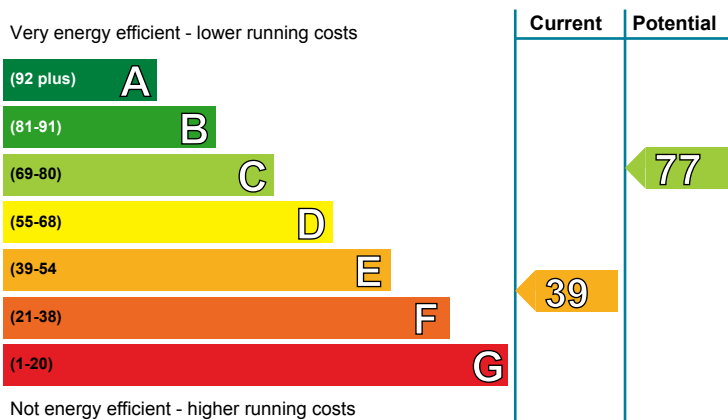
## Energy Efficiency Rating

This graph shows the current efficiency of your home, taking into account both energy efficiency and fuel costs. The higher this rating, the lower your fuel bills are likely to be.

The potential rating shows the effect of undertaking all of the improvement measures listed within your recommendations report.
