Home Report

8 Corsehillbank Street
Stewarton KA3 5BA

Single Survey

Property Address	8 Corsehillbank Street Stewarton KA3 5BA
Customer	Mrs Susan Millar
Prepared by	Graham + Sibbald LLP
Date of Inspection	26/06/2025

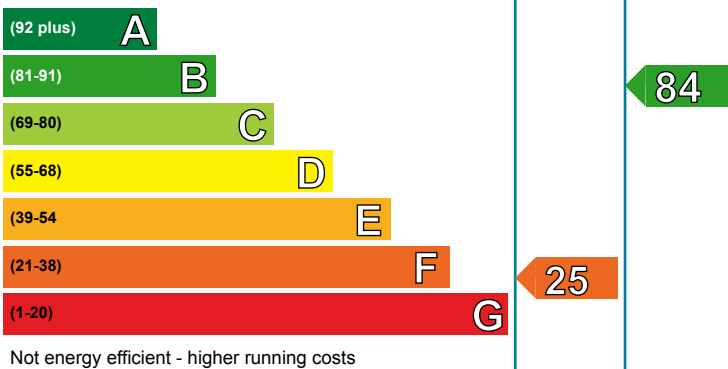
Energy Efficiency Rating

This graph shows the current efficiency of your home, taking into account both energy efficiency and fuel costs. The higher this rating, the lower your fuel bills are likely to be.

The potential rating shows the effect of undertaking all of the improvement measures listed within your recommendations report.

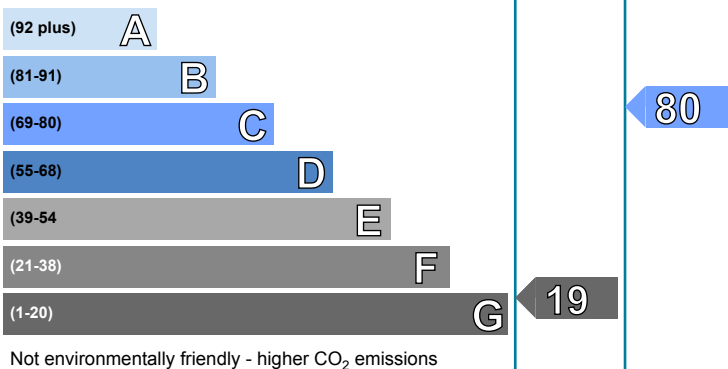
Environmental Impact (CO₂) Rating

This graph shows the effect of your home on the environment in terms of carbon dioxide (CO₂) emissions. The higher the rating, the less impact it has on the environment.
