# YOUR ONESURVEY HOME REPORT

7 Merrick Place Bourtreehill South, Irvine KA11 1ES

# SINGLE Survey

# Single Survey

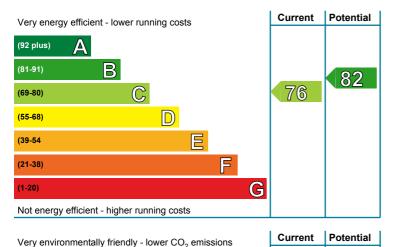
#### **Energy Efficiency Rating**

This graph shows the current efficiency of your home, taking into account both energy efficiency and fuel costs. The higher this rating, the lower your fuel bills are likely to be.
