Home Report

Scottish
Single Survey

Property address	The Oaks Wicketthorn Kirkpatrick Fleming Lockerbie DG11 3AS
Customer	Mr and Mrs Williams
Customer address	The Oaks Wicketthorn Kirkpatrick Fleming Lockerbie DG11 3AS
Prepared by	Shepherd Chartered Surveyors
Date of inspection	21/08/2025

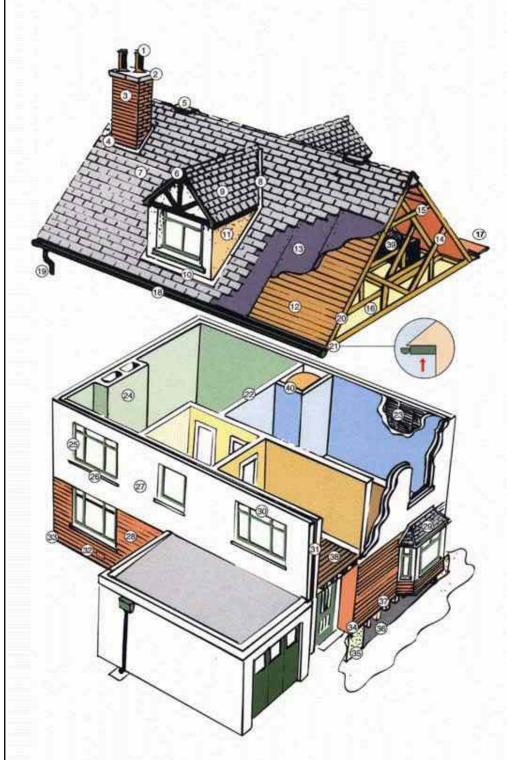
Sectional Diagram showing elements of a typical house

Reference may be made in this report to some or all of the above component parts of the property. This diagram may assist you in locating and understanding these items.

- (1) Chimney pots
- 2) Coping stone
- 3) Chimney head
- (4) Flashing
- 5) Ridge ventilation
- 6) Ridge board
- (7) Slates / tiles
- 8 Valley guttering
- 9 Dormer projection
- 10 Dormer flashing
- 11) Dormer cheeks
- (12) Sarking
- (13) Roof felt
- (14) Trusses
- (15) Collar
- 16) Insulation
- (17) Parapet gutter
- 18) Eaves guttering
- (19) Rainwater downpipe
- 20) Verge boards /skews
- 21) Soffit boards
- 22) Partition wall
- 23) Lath / plaster
- (24) Chimney breast
- 25) Window pointing
- 6) Window sills
- 27) Rendering
- (28) Brickwork / pointing
- 29) Bay window projection
- (30) Lintels
- (31) Cavity walls / wall ties
- 32) Subfloor ventilator
- (33) Damp proof course
- 34) Base course
- 35) Foundations
- 36) Solum
- 7) Floor joists
- 38) Floorboards
- 39) Water tank
- 40) Hot water tank
