# Home Report

# Scottish Single Survey

| Property address | Flat 4<br>Hawthorn Court<br>148c Brownside Road<br>Cambuslang<br>Glasgow<br>G72 8AH |
| Prepared by | Shepherd Chartered Surveyors |

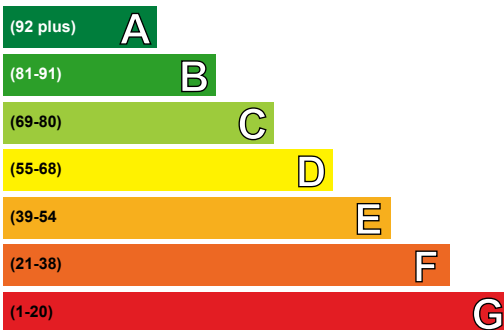
\* based upon the cost of energy for heating, hot water, lighting and ventilation, calculated using standard assumptions

Very energy efficient - lower running costs

Not energy efficient - higher running costs
