Home Report

Single Survey

survey report on:

Property address	St. Margarets Eaglesfield Lockerbie DG11 3PD
Customer	Miss Ceilidh Barron and Mr Paul Richardson
Customer address	St. Margarets Eaglesfield Lockerbie DG11 3PD
Prepared by	Shepherd Chartered Surveyors
Date of inspection	19/11/2025

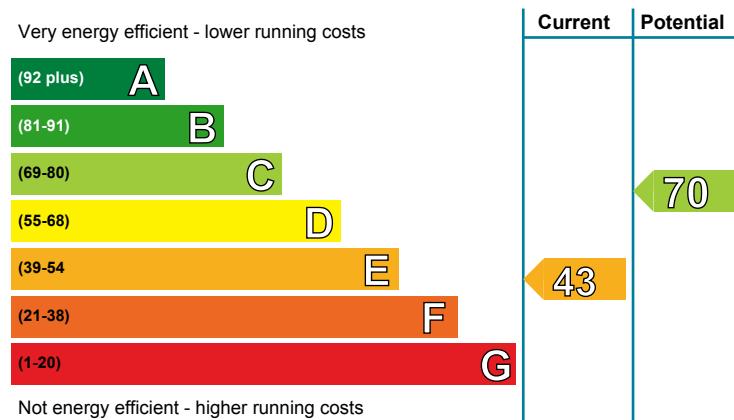
Energy Efficiency Rating

This graph shows the current efficiency of your home, taking into account both energy efficiency and fuel costs. The higher this rating, the lower your fuel bills are likely to be.

Your current rating is **band E (43)**. The average rating for EPCs in Scotland is **band D (61)**.

The potential rating shows the effect of undertaking all of the improvement measures listed within your recommendations report.

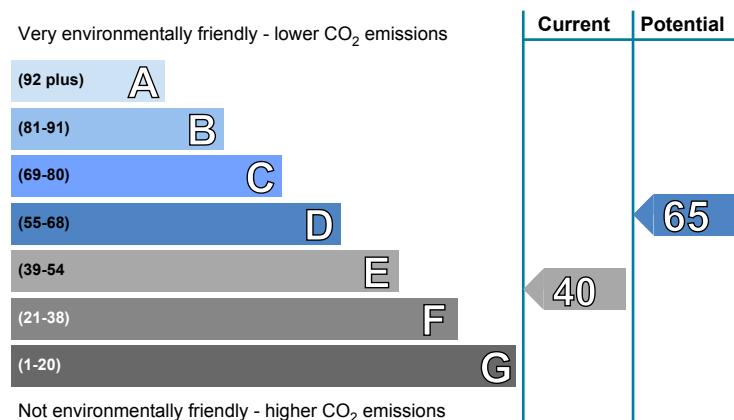
Environmental Impact (CO₂) Rating

This graph shows the effect of your home on the environment in terms of carbon dioxide (CO₂) emissions. The higher the rating, the less impact it has on the environment.
