# Home Report

# Scottish Single Survey

<b>Property address</b>	9 Greenknowe Avenue Annan DG12 6ER
<b>Customer</b>	Mr and Mrs Maddison
<b>Customer address</b>	9 Greenknowe Avenue Annan DG12 6ER
<b>Prepared by</b>	Shepherd Chartered Surveyors
<b>Date of inspection</b>	14/01/2026

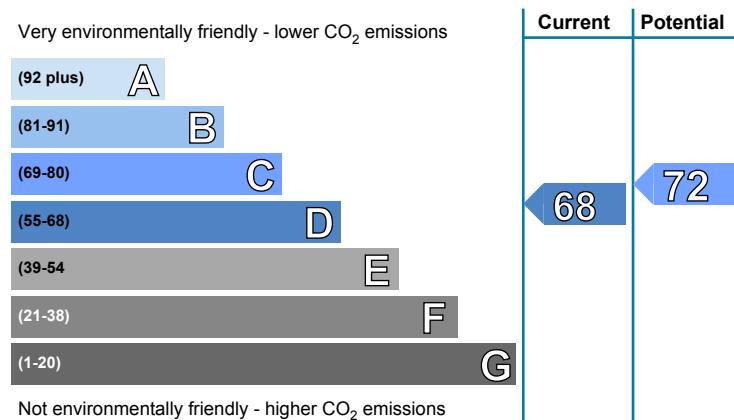
### Environmental Impact (CO<sub>2</sub>) Rating

This graph shows the effect of your home on the environment in terms of carbon dioxide (CO<sub>2</sub>) emissions. The higher the rating, the less impact it has on the environment.
