1 GREENBANK DRIVE
GREENBANK
EDINBURGH
EH10 5RE

Home Report

**Energy
Performance
Certificate**

Scottish Single Survey

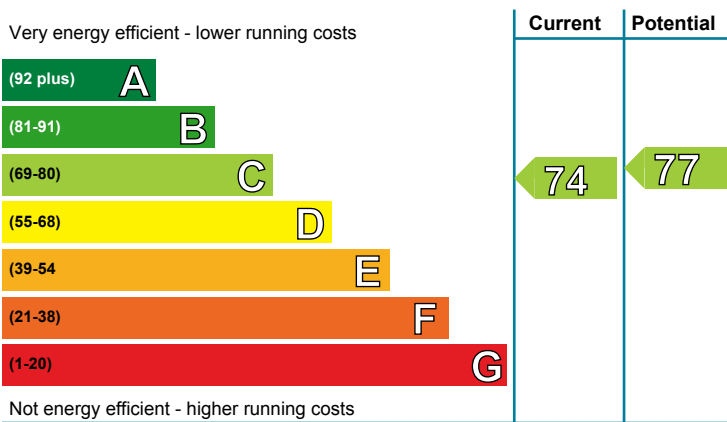
Energy Efficiency Rating

This graph shows the current efficiency of your home, taking into account both energy efficiency and fuel costs. The higher this rating, the lower your fuel bills are likely to be.

Your current rating is **band C (74)**. The average rating for EPCs in Scotland is **band D (61)**.

The potential rating shows the effect of undertaking all of the improvement measures listed within your recommendations report.

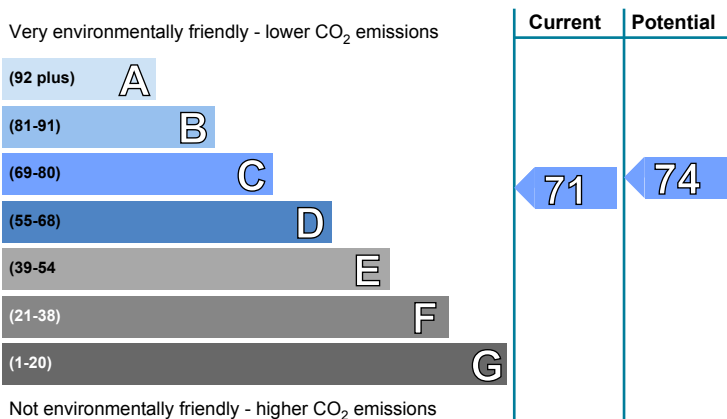
Environmental Impact (CO₂) Rating

This graph shows the effect of your home on the environment in terms of carbon dioxide (CO₂) emissions. The higher the rating, the less impact it has on the environment.

The potential rating shows the effect of undertaking all of the improvement measures listed within your recommendations report.
