# YOUR ONESURVEY HOME REPORT

4 Blaven Head  
Bourtreehill North, Irvine  
KA11 1LF

# SINGLE SURVEY

A report on the condition of the property, with categories  
being rated from 1 to 3.

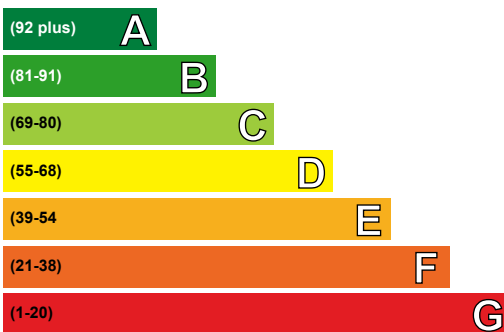
Very energy efficient - lower running costs

Not energy efficient - higher running costs

\* based upon the cost of energy for heating, hot water, lighting and ventilation, calculated using standard assumptions

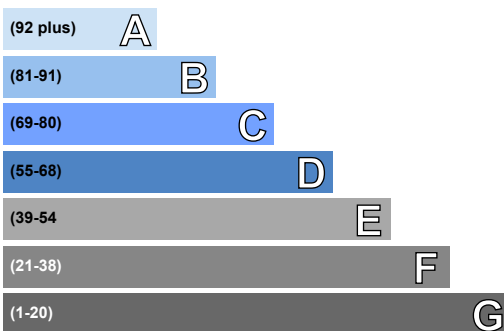
Very environmentally friendly - lower CO<sub>2</sub> emissions

Not environmentally friendly - higher CO<sub>2</sub> emissions

The potential rating shows the effect of undertaking all of the improvement measures listed within your recommendations report.
