YOUR ONESURVEY
HOME REPORT

91 Market Street
Musselburgh
EH21 6PS

Single Survey

Prepared by	Edward Cook, MSc MRICS J & E Shepherd - Musselburgh
--------------------	--

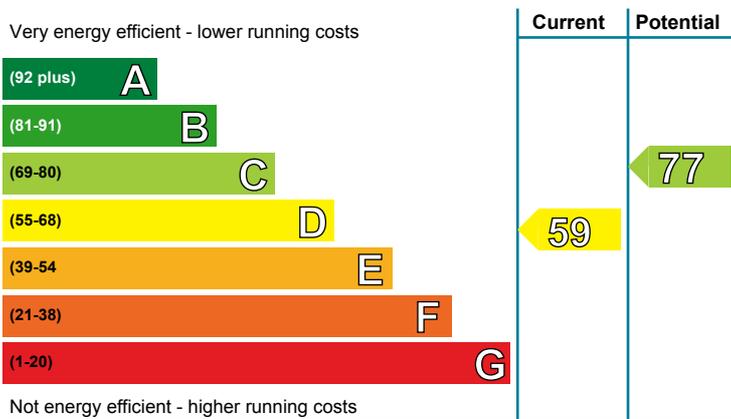
Energy Efficiency Rating

This graph shows the current efficiency of your home, taking into account both energy efficiency and fuel costs. The higher this rating, the lower your fuel bills are likely to be.

Your current rating is **band D (59)**. The average rating for EPCs in Scotland is **band D (61)**.

The potential rating shows the effect of undertaking all of the improvement measures listed within your recommendations report.

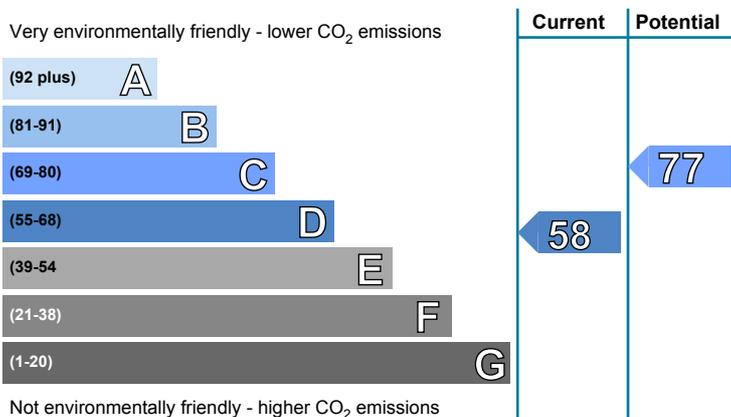
Environmental Impact (CO₂) Rating

This graph shows the effect of your home on the environment in terms of carbon dioxide (CO₂) emissions. The higher the rating, the less impact it has on the environment.
