Home Report

54 Bellevue Crescent
Ayr KA7 2DR

Single Survey

Property Address	54 Bellevue Crescent Ayr KA7 2DR
Customer	Mr Rame Bajis
Prepared by	Graham + Sibbald Property Consultants Limited
Date of Inspection	02/02/2026

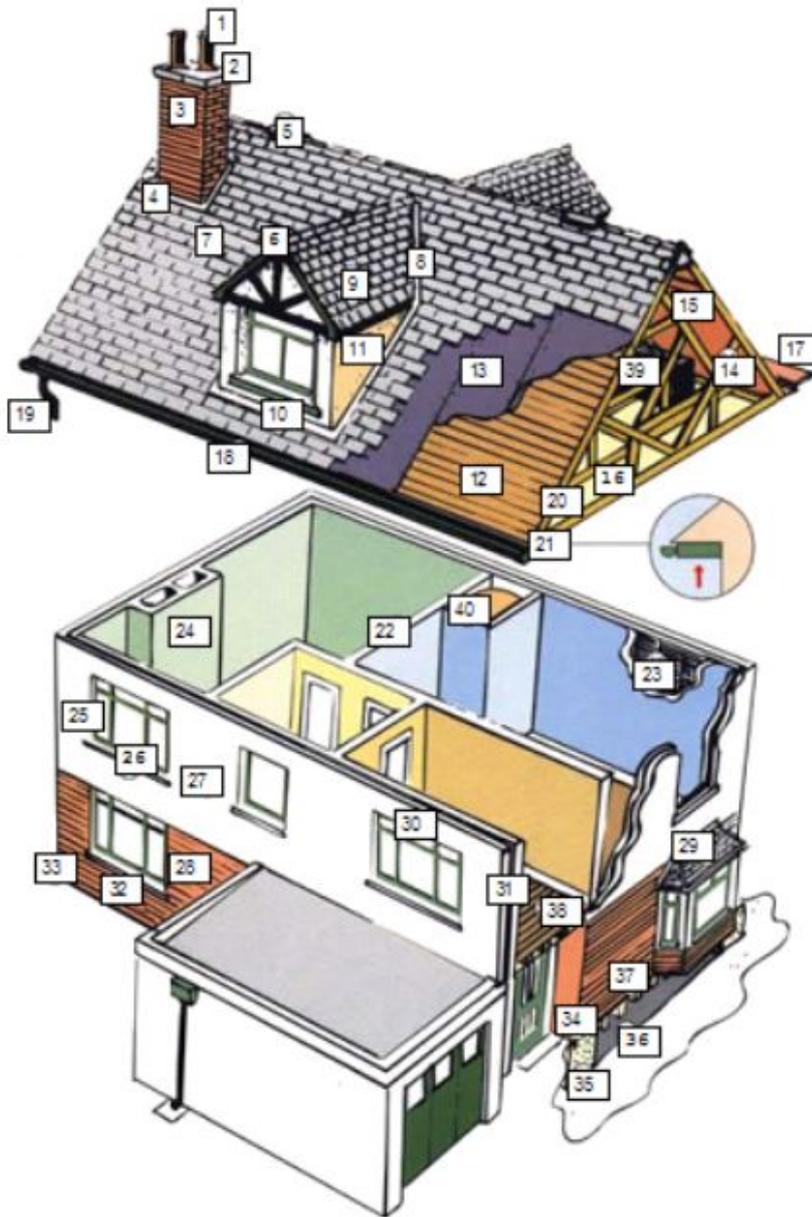
Sectional diagram showing elements of a typical house

1	Chimney pots
2	Coping stone
3	Chimney head
4	Flashing
5	Ridge ventilation
6	Ridge board
7	Slates / tiles
8	Valley guttering
9	Dormer projection
10	Dormer flashing
11	Dormer cheeks
12	Sarking
13	Roof felt
14	Trusses
15	Collar
16	Insulation
17	Parapet gutter
18	Eaves guttering
19	Rainwater downpipe
20	Verge boards / skews
21	Soffit boards
22	Partition wall
23	Lath / plaster
24	Chimney breast
25	Window pointing
26	Window sills
27	Rendering
28	Brickwork / pointing
29	Bay window projection
30	Lintels
31	Cavity walls / wall ties
32	Subfloor ventilator
33	Damp proof course
34	Base course
35	Foundations
36	Solum
37	Floor joists
38	Floorboards
39	Water tank
40	Hot water tank

Reference may be made in this report to some or all of the above component parts of the property. This diagram may assist you in locating and understanding these items.

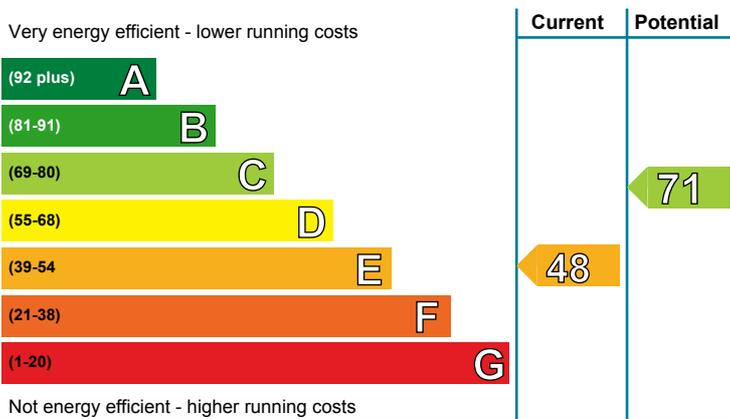
Energy Efficiency Rating

This graph shows the current efficiency of your home, taking into account both energy efficiency and fuel costs. The higher this rating, the lower your fuel bills are likely to be.

Your current rating is **band E (48)**. The average rating for EPCs in Scotland is **band D (61)**.

The potential rating shows the effect of undertaking all of the improvement measures listed within your recommendations report.

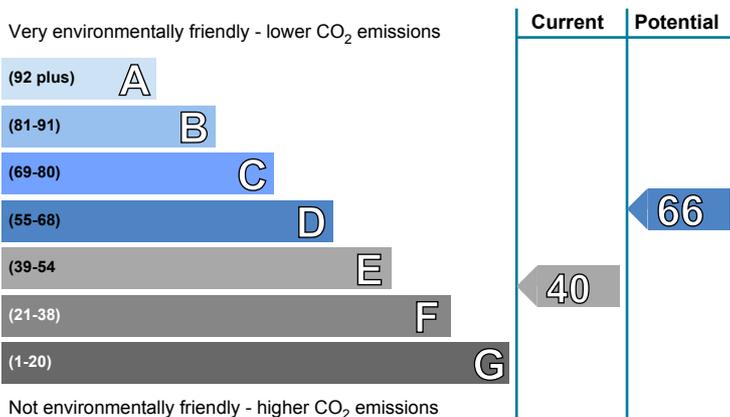
Environmental Impact (CO₂) Rating

This graph shows the effect of your home on the environment in terms of carbon dioxide (CO₂) emissions. The higher the rating, the less impact it has on the environment.
