Home Report

Single Survey

Property address	4 Roe Court Cambuslang Glasgow G72 6WR
Customer	Tadej Kovacic
Customer address	4 Roe Court Cambuslang Glasgow G72 6WR
Prepared by	Shepherd Chartered Surveyors
Date of inspection	05/03/2026

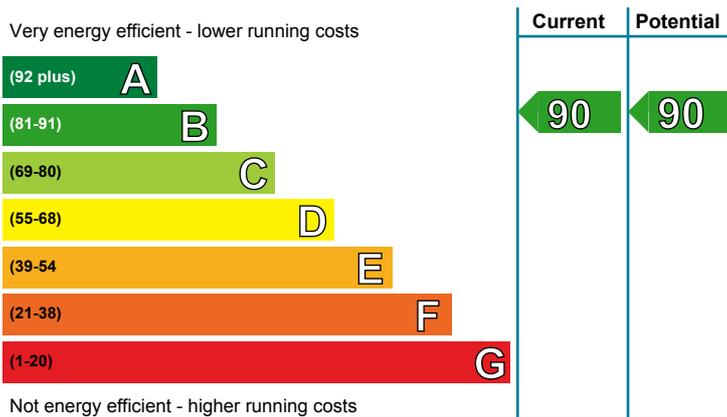
Energy Efficiency Rating

This graph shows the current efficiency of your home, taking into account both energy efficiency and fuel costs. The higher this rating, the lower your fuel bills are likely to be.

Your current rating is **band B (90)**. The average rating for EPCs in Scotland is **band D (61)**.

The potential rating shows the effect of undertaking all of the improvement measures listed within your recommendations report.

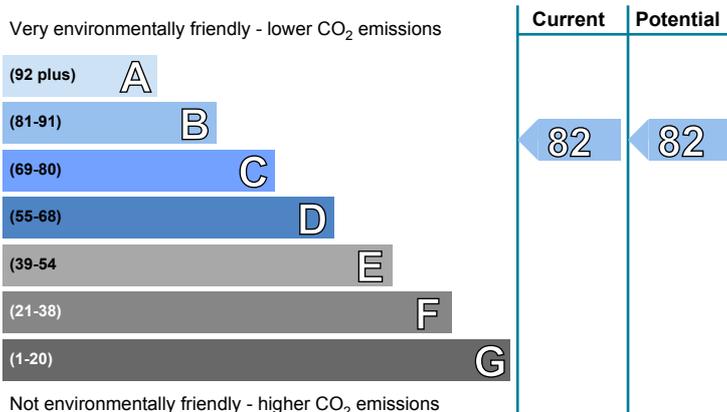
Environmental Impact (CO₂) Rating

This graph shows the effect of your home on the environment in terms of carbon dioxide (CO₂) emissions. The higher the rating, the less impact it has on the environment.
