# Home Report

11 Clarence Street  
Glasgow G81 2HU

# Single Survey

<b>Property Address</b>	11 Clarence Street Glasgow G81 2HU
<b>Customer</b>	Younis Mohammed
<b>Prepared by</b>	Graham + Sibbald Property Consultants Limited
<b>Date of Inspection</b>	25/02/2026

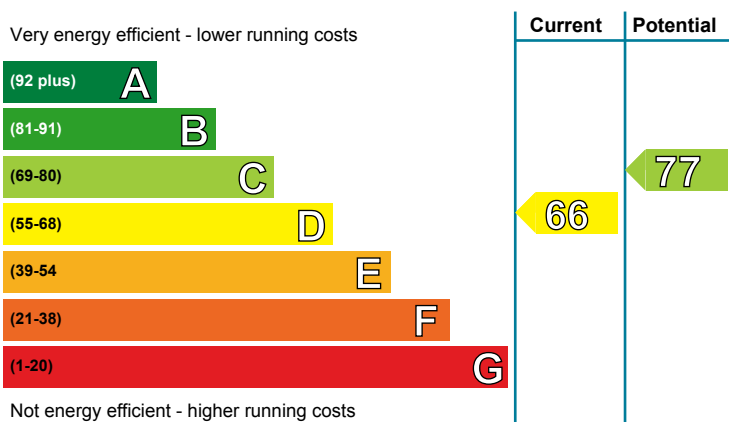
## Energy Efficiency Rating

This graph shows the current efficiency of your home, taking into account both energy efficiency and fuel costs. The higher this rating, the lower your fuel bills are likely to be.

Your current rating is **band D (66)**. The average rating for EPCs in Scotland is **band D (61)**.

The potential rating shows the effect of undertaking all of the improvement measures listed within your recommendations report.

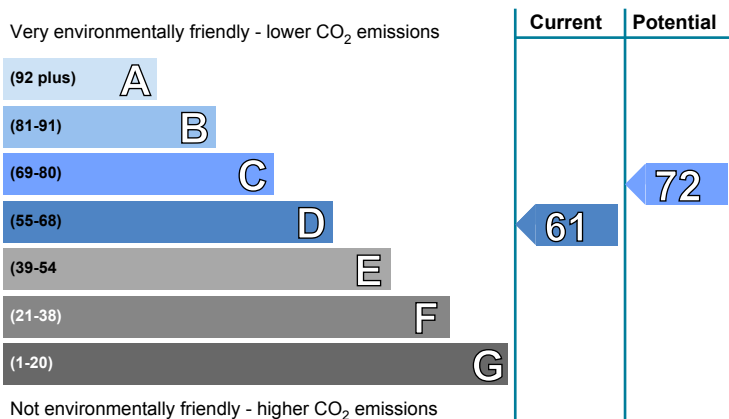
## Environmental Impact (CO<sub>2</sub>) Rating

This graph shows the effect of your home on the environment in terms of carbon dioxide (CO<sub>2</sub>) emissions. The higher the rating, the less impact it has on the environment.
