Home Report

22 Dean Road
Kilmarnock KA3 1RR

Single Survey

Property Address	22 Dean Road Kilmarnock KA3 1RR
Customer	Mr Nairn Miller
Prepared by	Graham + Sibbald Property Consultants Limited
Date of Inspection	25/05/2026

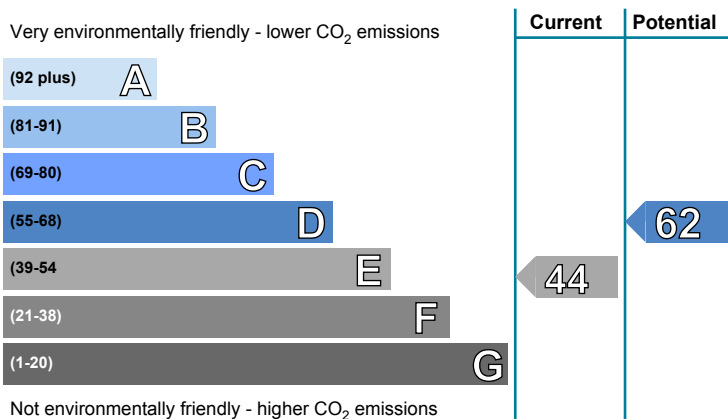
Environmental Impact (CO₂) Rating

This graph shows the effect of your home on the environment in terms of carbon dioxide (CO₂) emissions. The higher the rating, the less impact it has on the environment.
