Cottage 1 Craiglea,
Loch Doon,
Dalmellington,
AYR,
KA6 7QE

Home Report

Single Survey

Property Address	Cottage 1 Craiglea, Loch Doon, Dalmellington, AYR, KA6 7QE
Reference	1623782
Customer Name	Mary Hunt
Date of Inspection	12th June 2026
Surveyor's name, qualifications and office	Ross Cooper , BSc (Hons) AssocRICS DM Hall LLP Chartered Surveyors Eldo House, Monkton Road, Prestwick, KA9 2PB Tel: 01292 286974 email: ayrshireresidential@dmhall.co.uk
Prepared By	DM Hall LLP

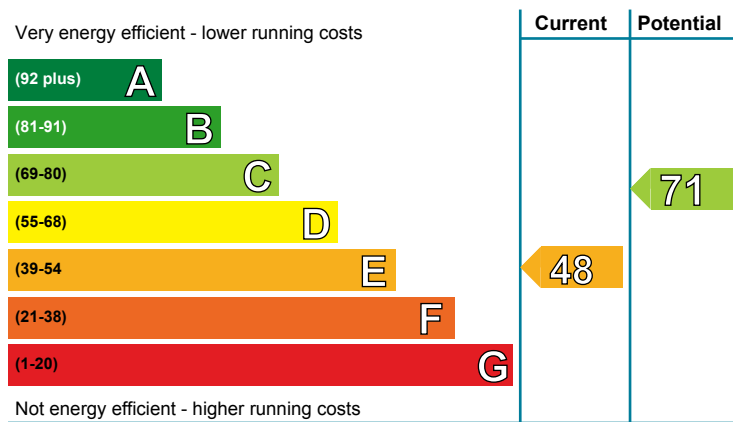
Energy Efficiency Rating

This graph shows the current efficiency of your home, taking into account both energy efficiency and fuel costs. The higher this rating, the lower your fuel bills are likely to be.

Your current rating is **band E (48)**. The average rating for EPCs in Scotland is **band D (61)**.

The potential rating shows the effect of undertaking all of the improvement measures listed within your recommendations report.

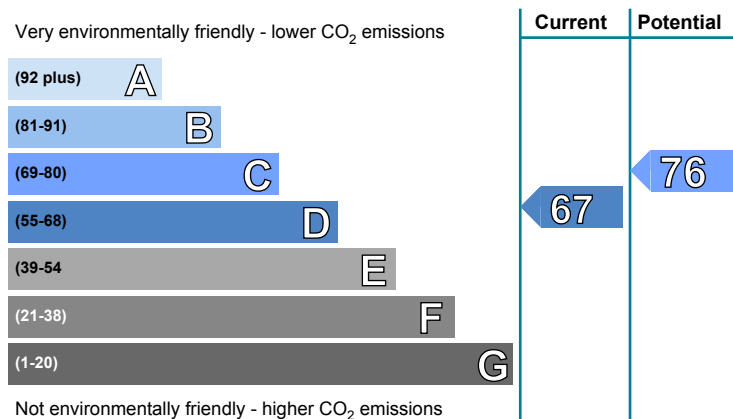
Environmental Impact (CO₂) Rating

This graph shows the effect of your home on the environment in terms of carbon dioxide (CO₂) emissions. The higher the rating, the less impact it has on the environment.
